Australian
BORDER FORCE

Detections of asbestos in imported goods

The following images are examples of imported goods which were subjected to sampling and testing at the border, and subsequently found to contain asbestos. The *Country shipped from* is the country the goods were supplied from to Australia. For some of the vehicle examples, this does not reflect the original country of manufacture.

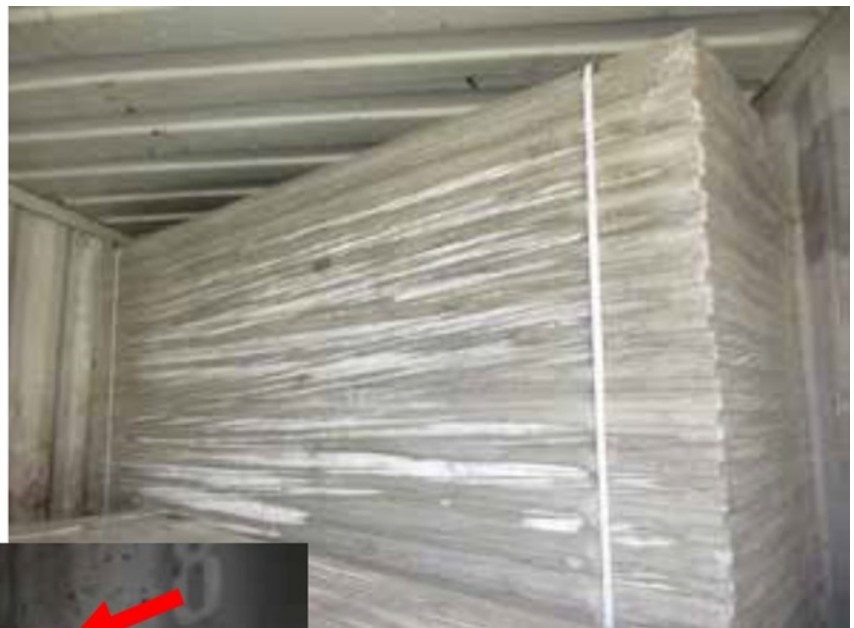
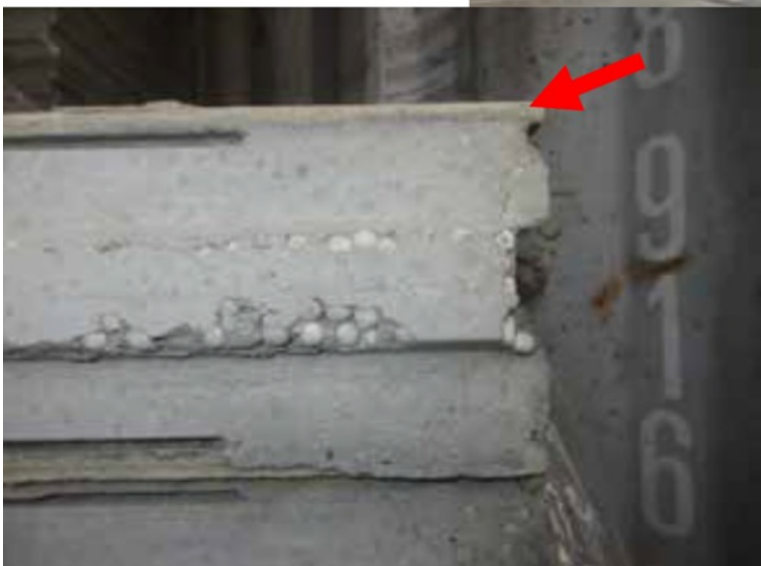
1. Chrysotile Asbestos detected in outer layers (fibre board) of goods described as Expanded Polystyrene Sandwich panels, intended for use as wall panels. Country shipped from: China

Arrow indicates the fibre board with asbestos.

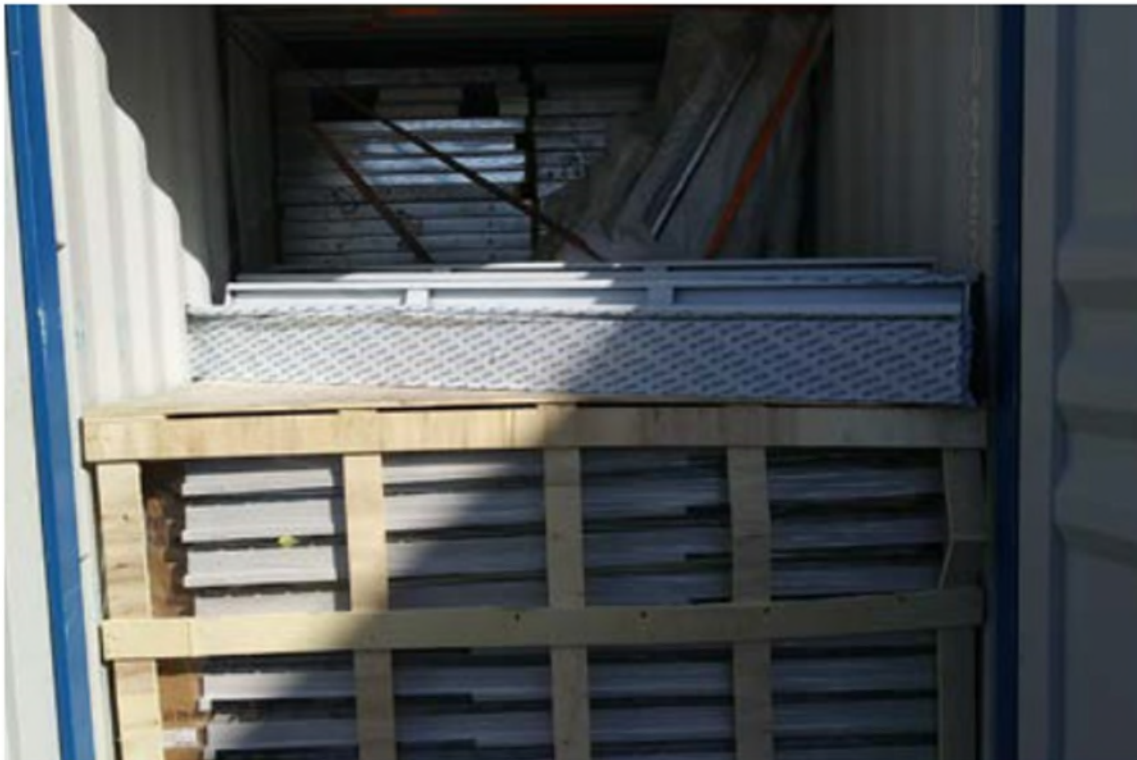
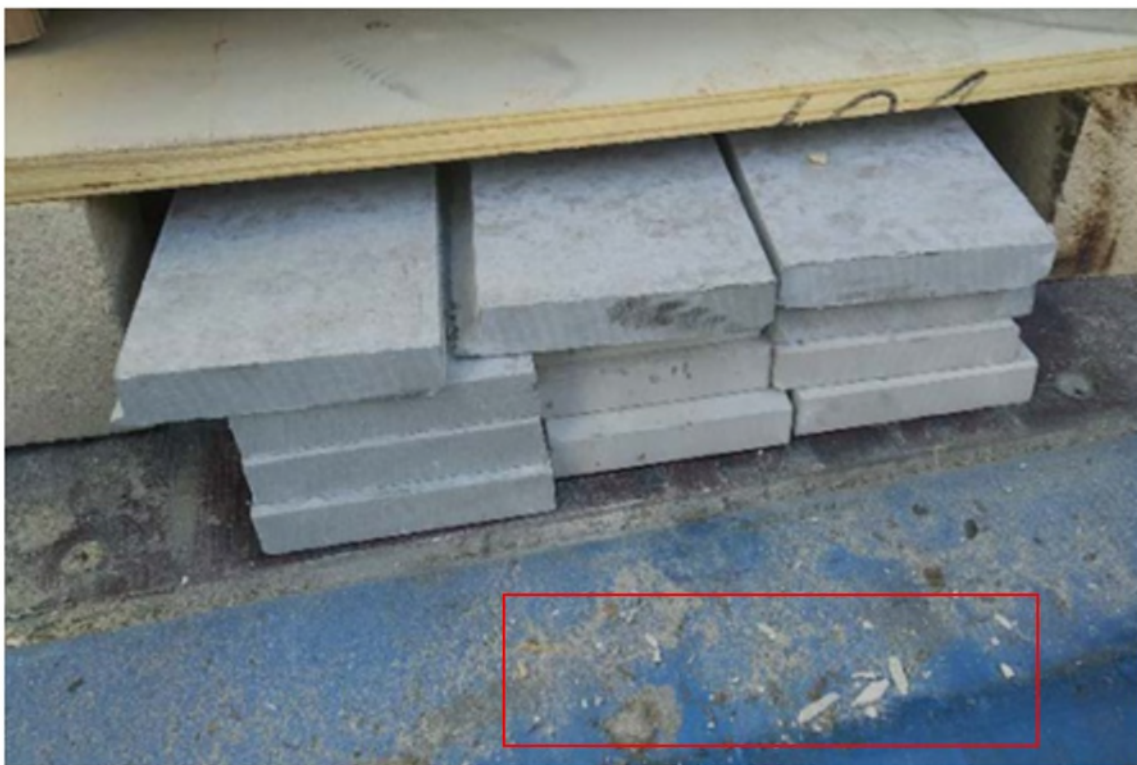
2. Chrysotile asbestos detected in cement fibre boards. Country shipped from: China

Debris from the boards was present on the container floor.

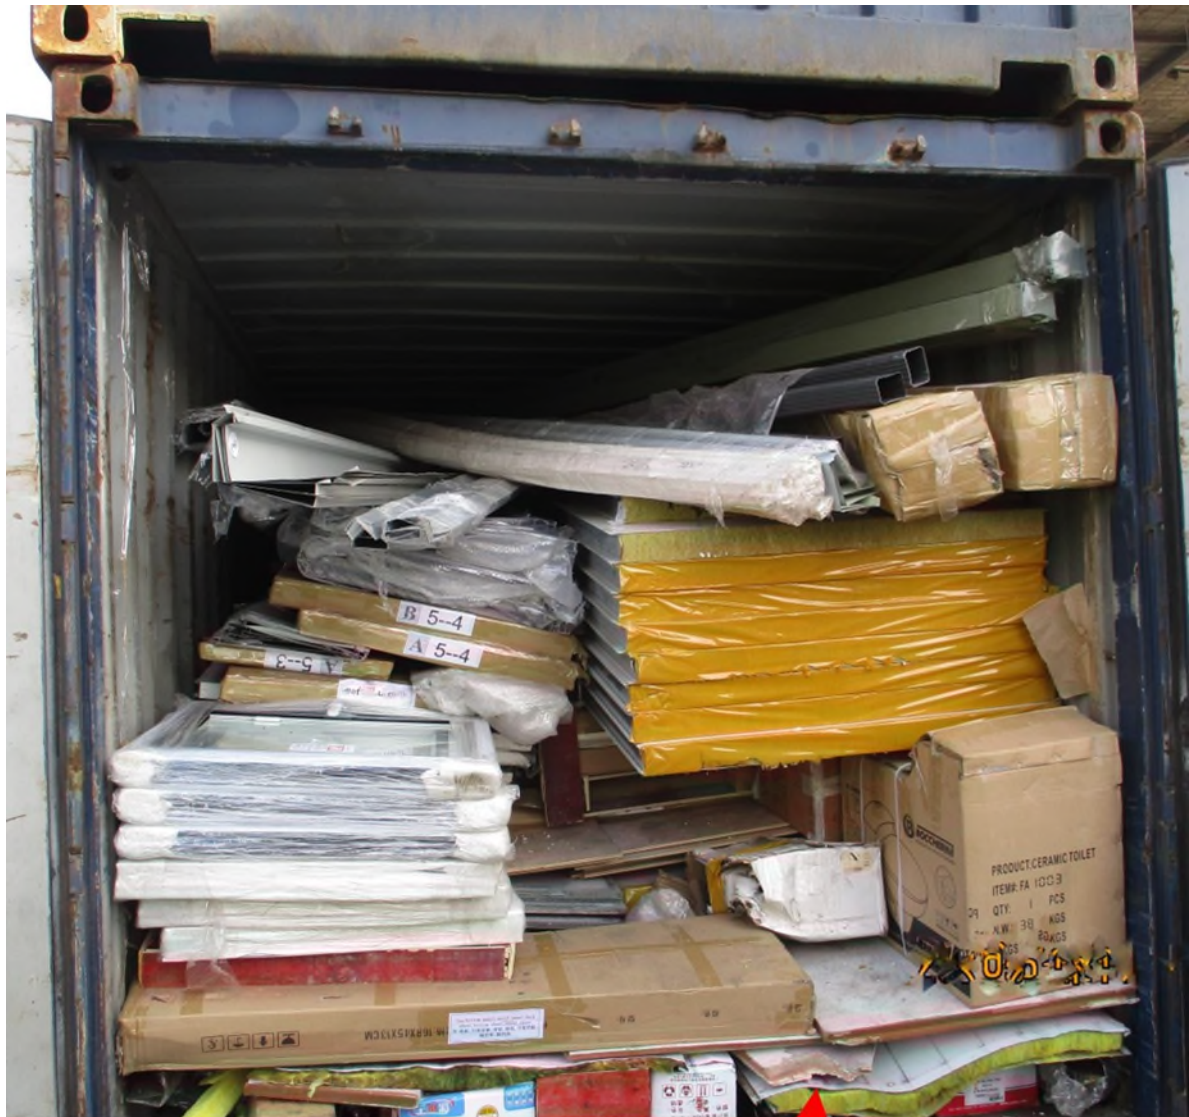
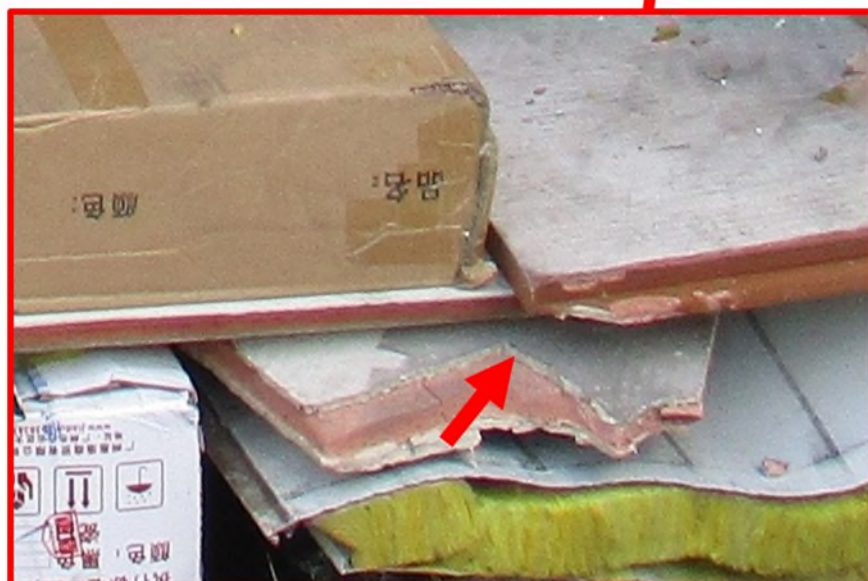
3. Chrysotile asbestos detected in cement fibre boards, shipped as part of a prefabricated house kit.
Country shipped from: China

Arrow indicates outer section of cement fibre board containing asbestos.

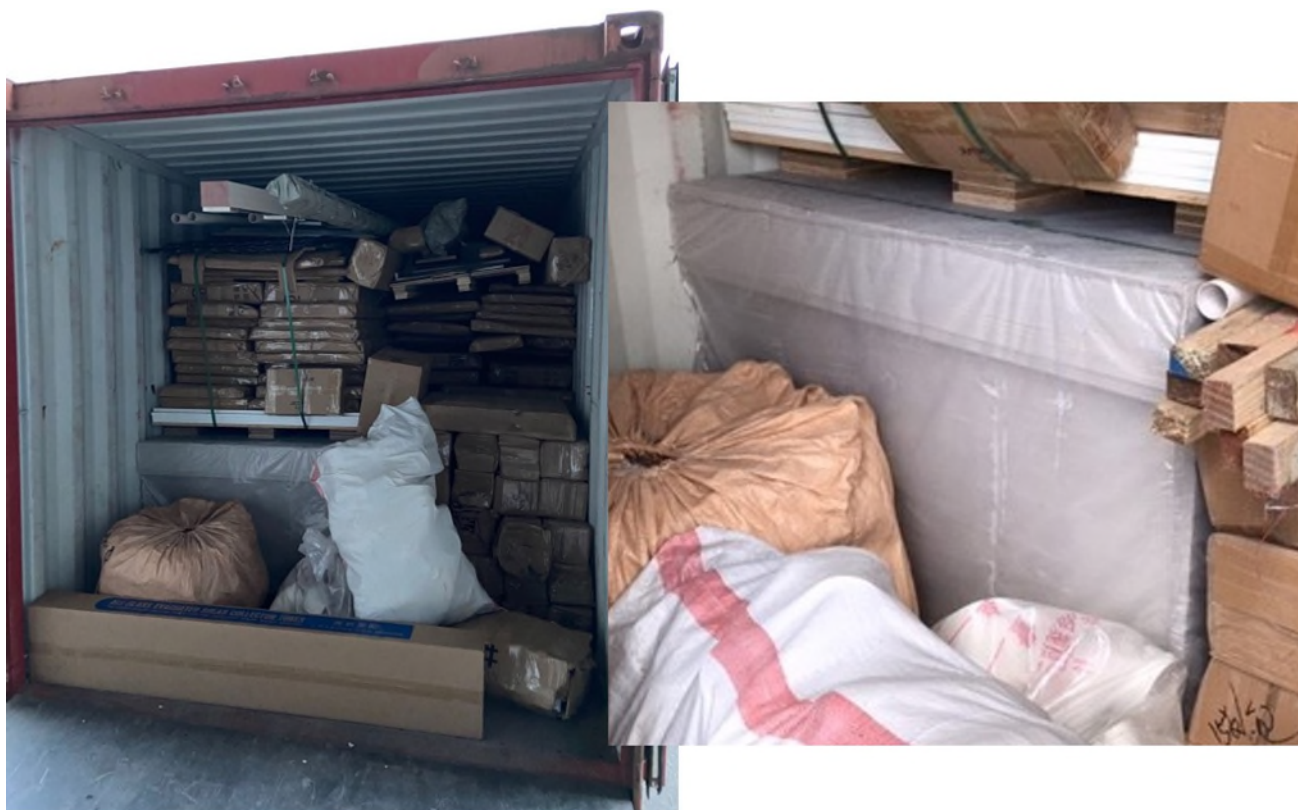
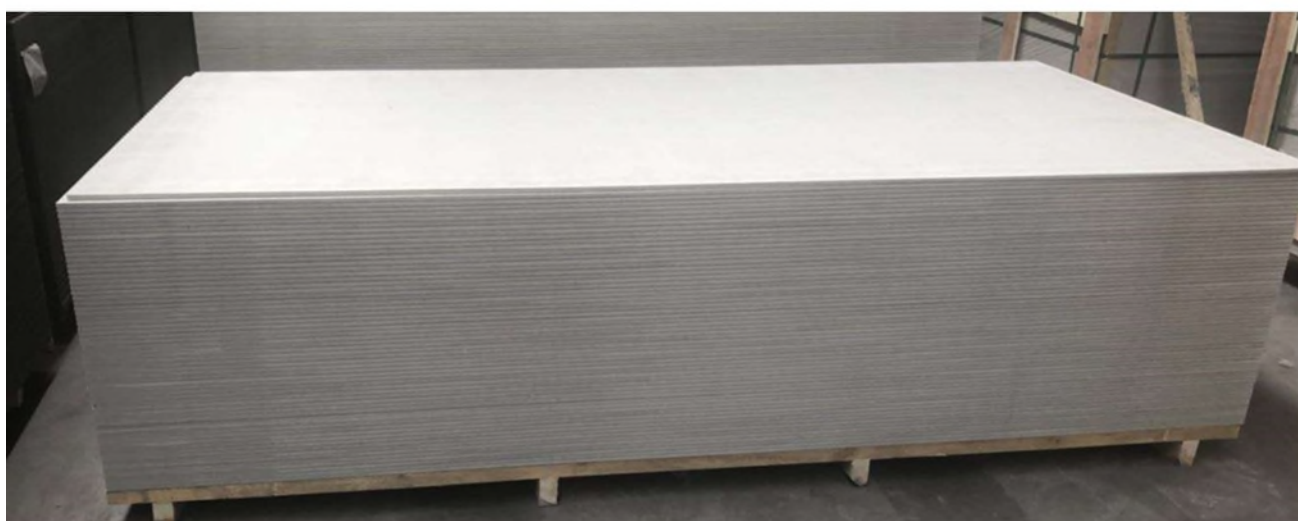
4. Chrysotile asbestos detected in cement fibre boards, shipped with other building goods. Country shipped from: China

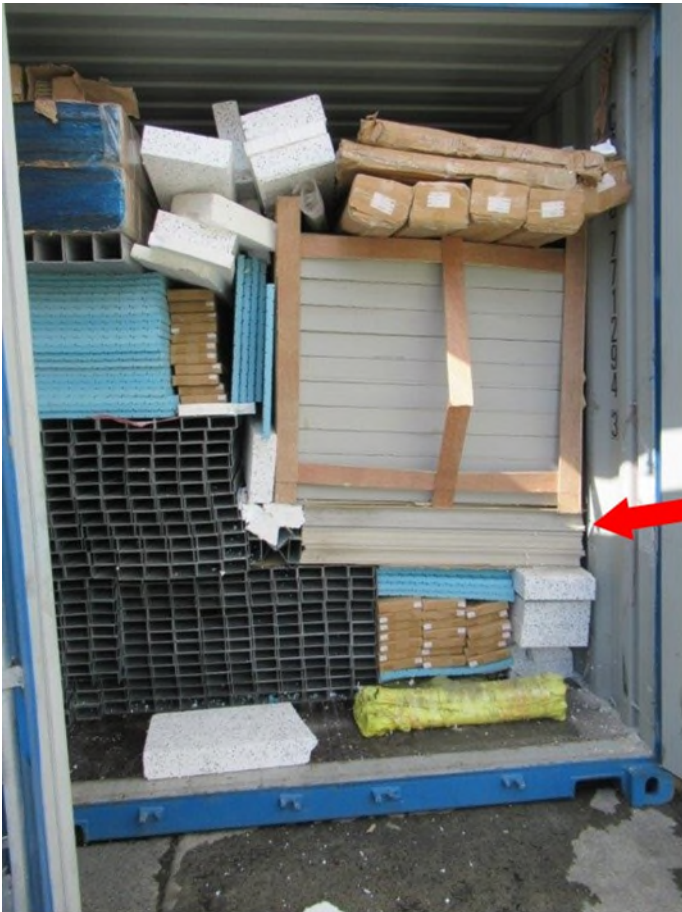
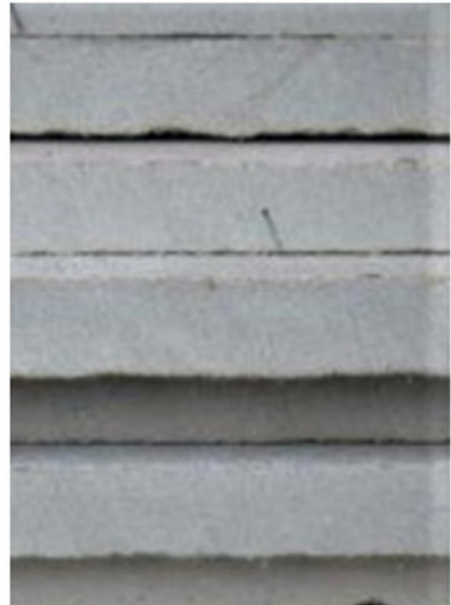
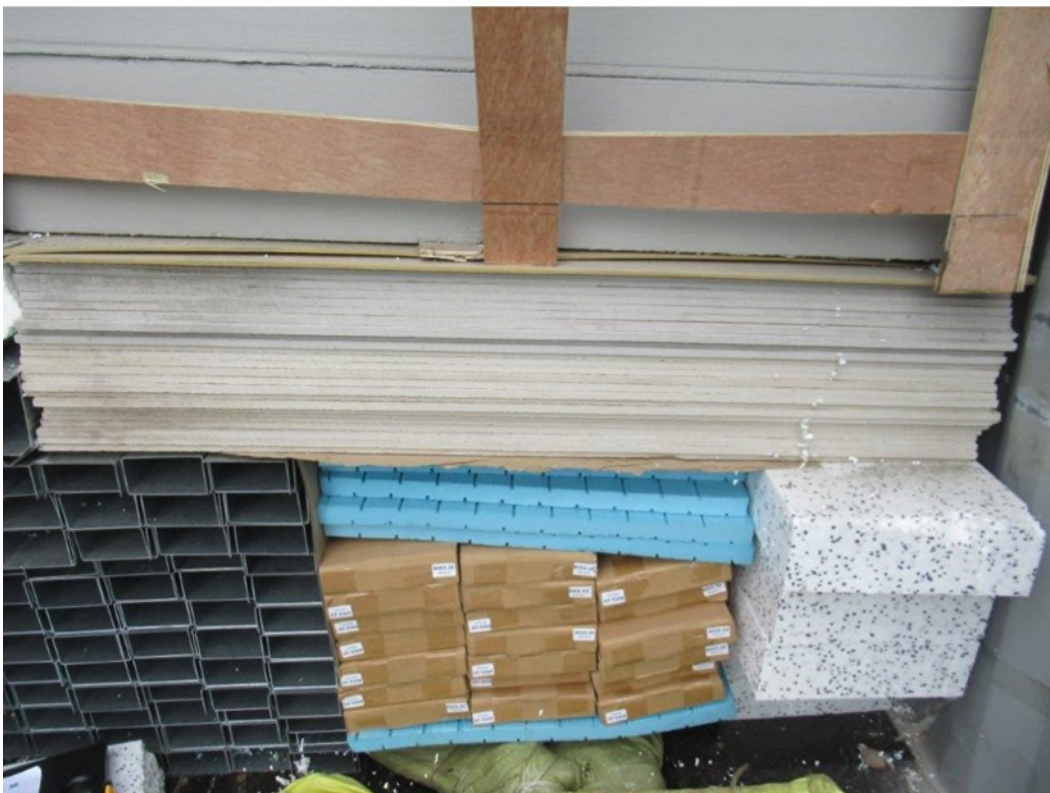
5. Chrysotile asbestos detected in cement fibre boards, shipped as part of a prefabricated house kit.
Country shipped from: China

Boards visibly contain fibre material

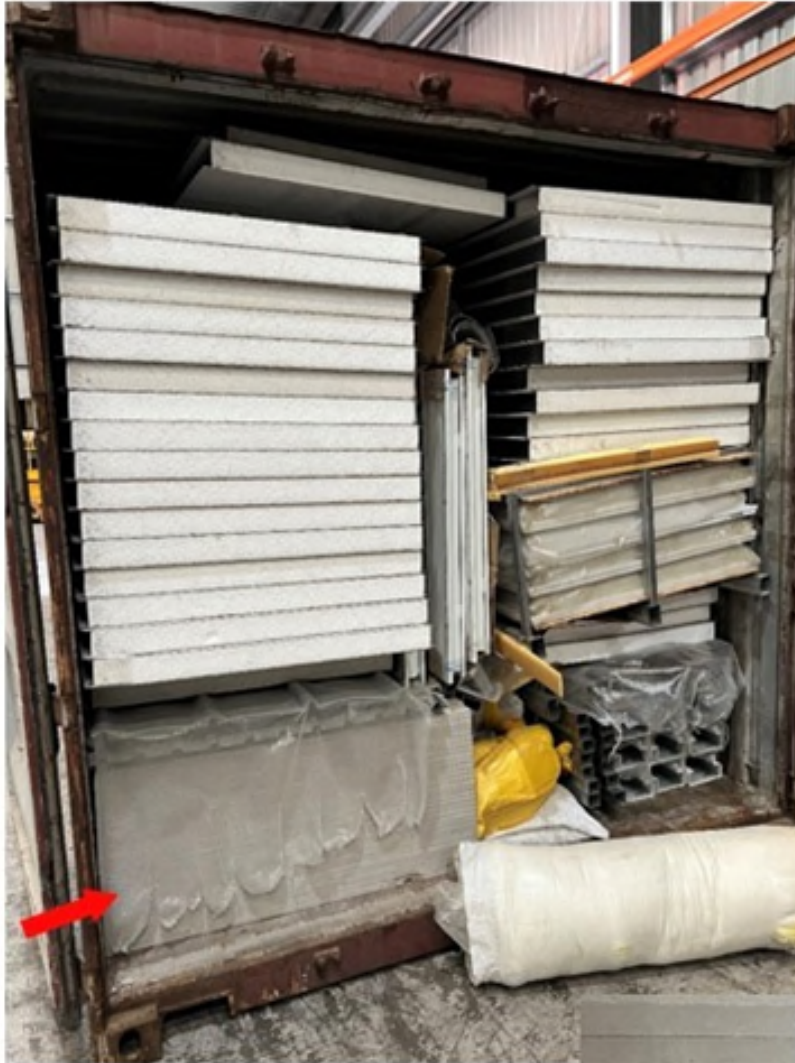
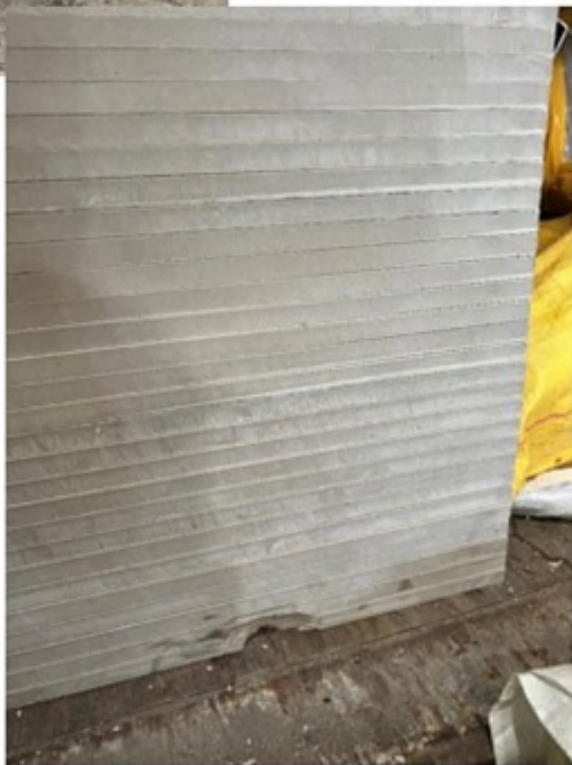
6. Chrysotile asbestos detected in cement fibre boards, shipped as part of a prefabricated house kit.
Country shipped from: China

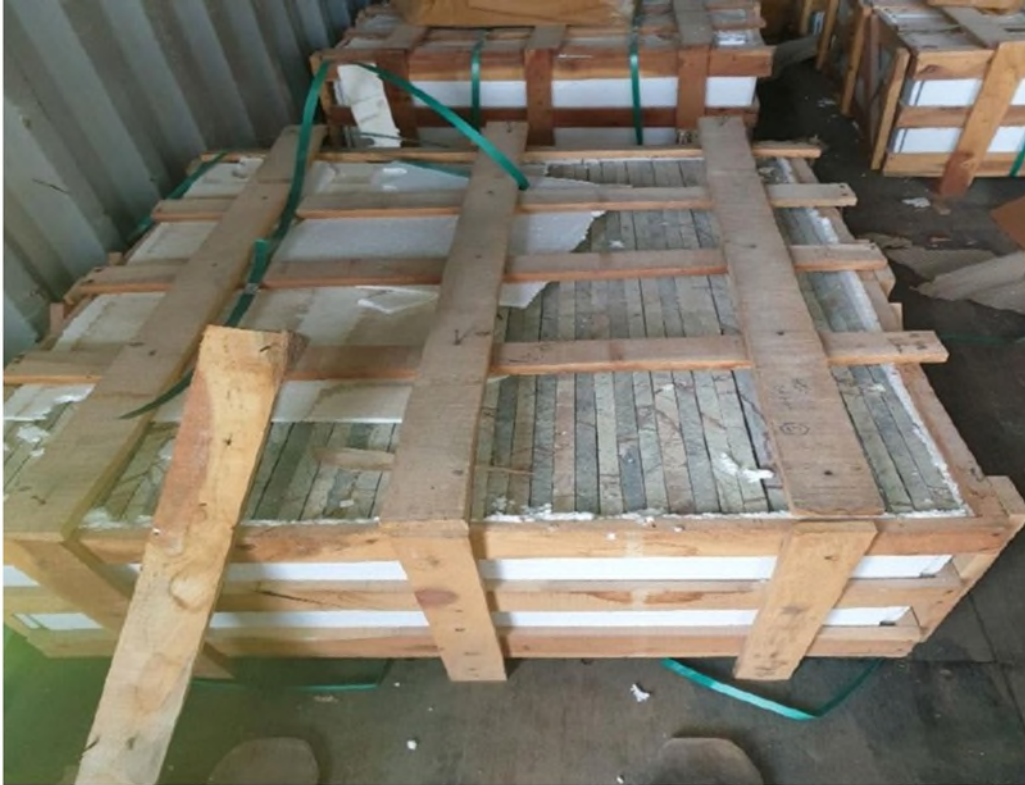
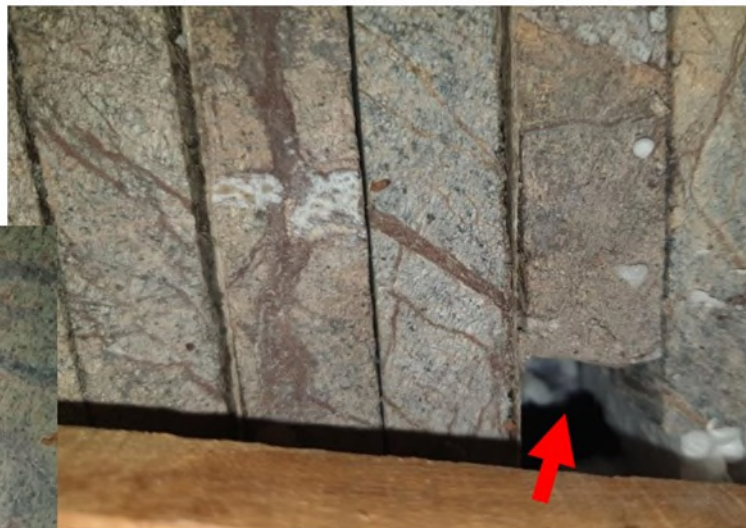
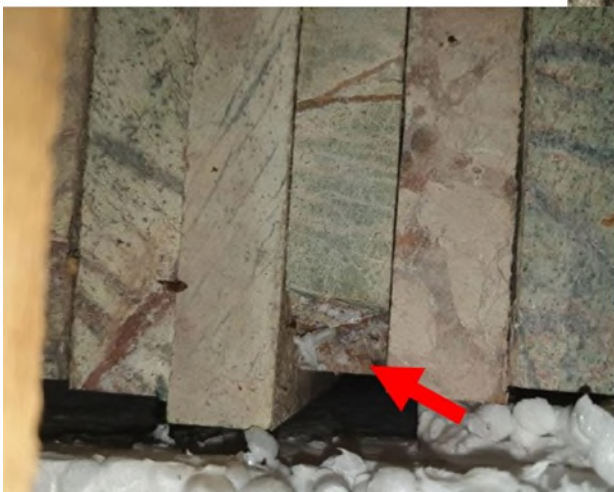
7. Naturally occurring chrysotile asbestos detected in mineral slabs described as Radasthan green and brown marble. Country shipped from: India.

Arrows indicate the locations the samples were taken from for testing.

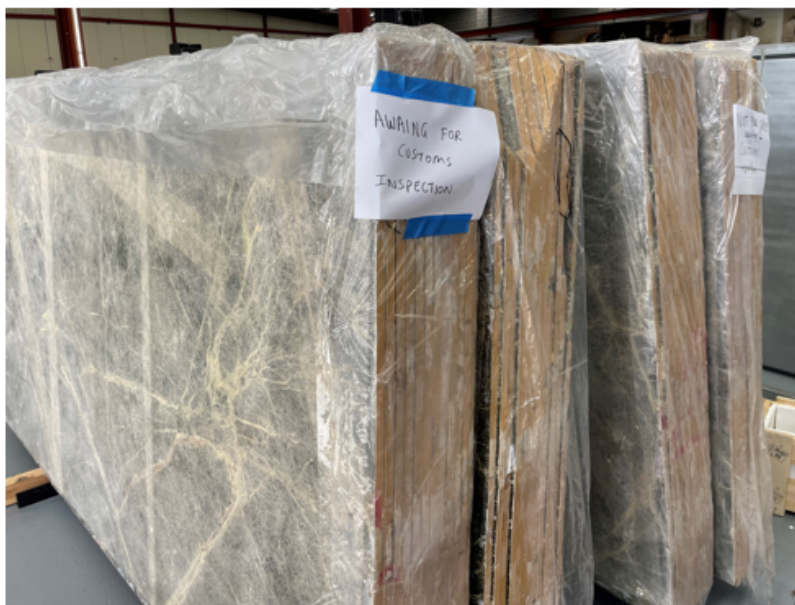
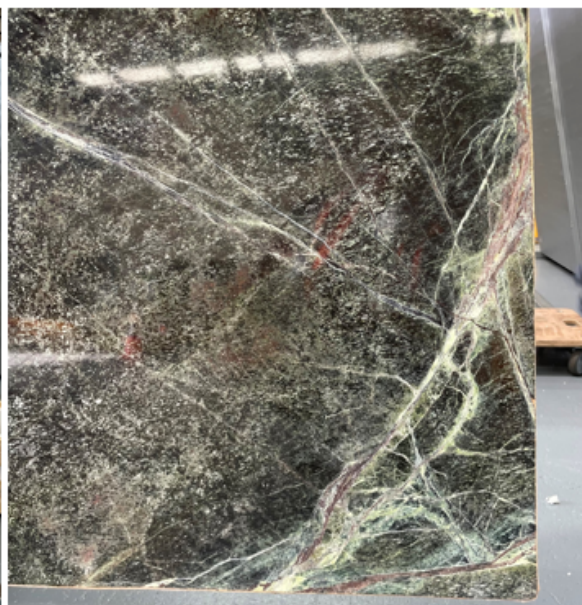
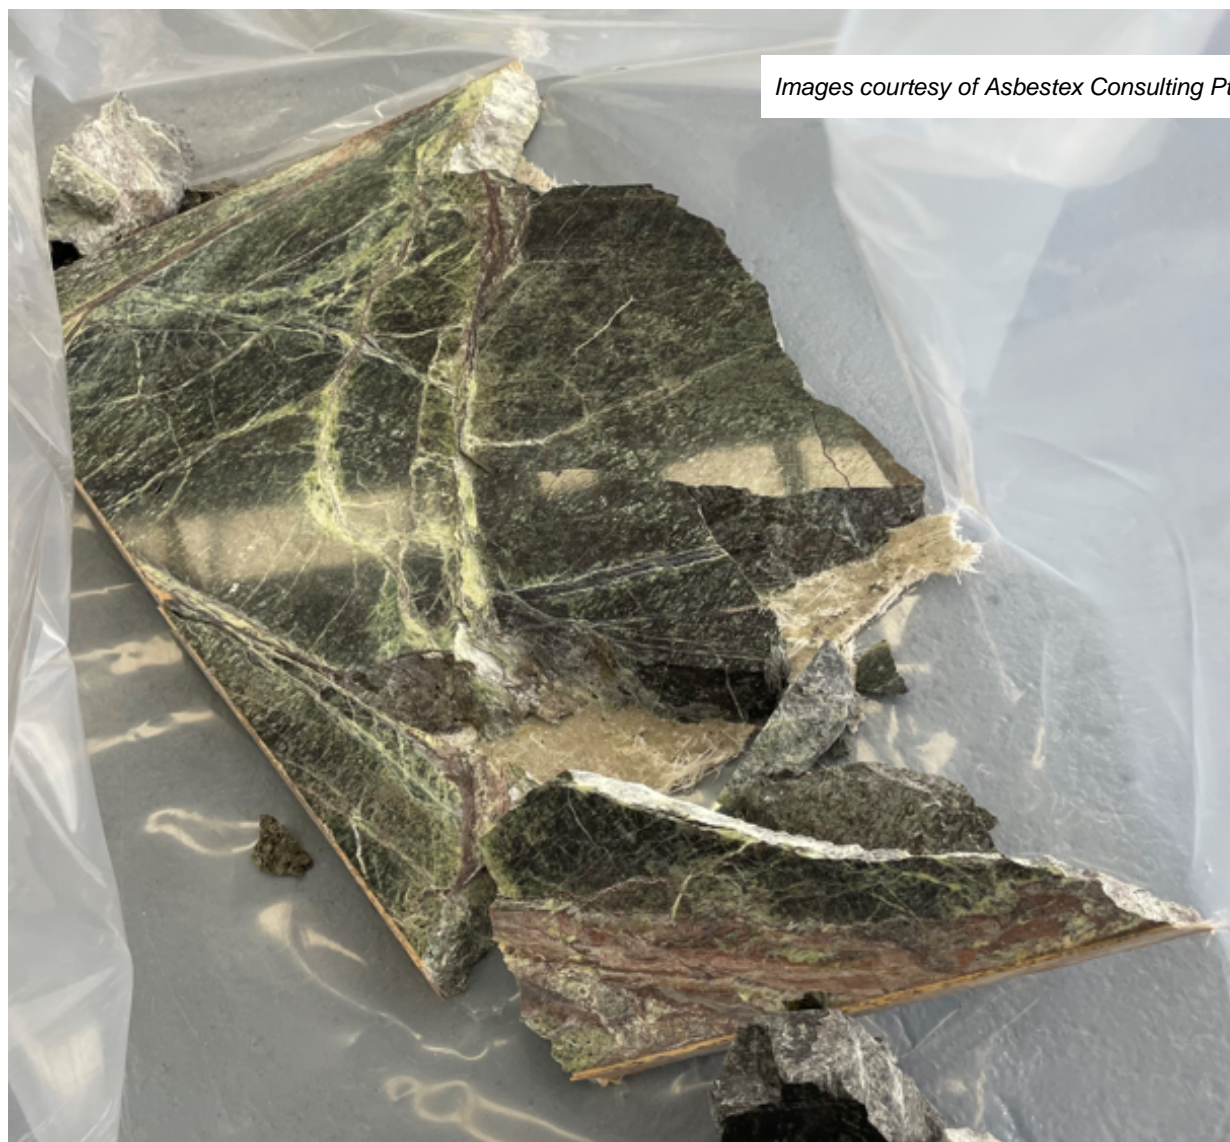
8. Naturally occurring chrysotile asbestos detected in mineral slabs described as Rain Forest Green marble. Country shipped from: India.

Sample obtained. Chrysotile asbestos was present in the green ore throughout the sample.

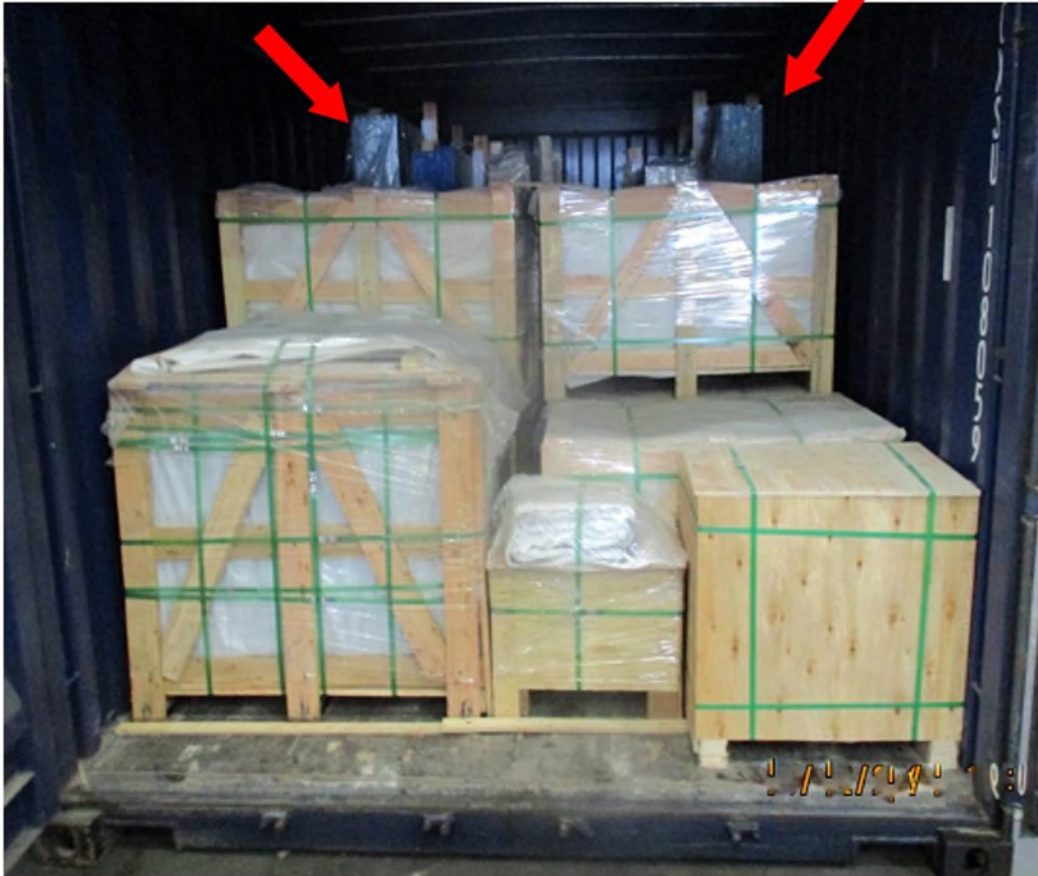
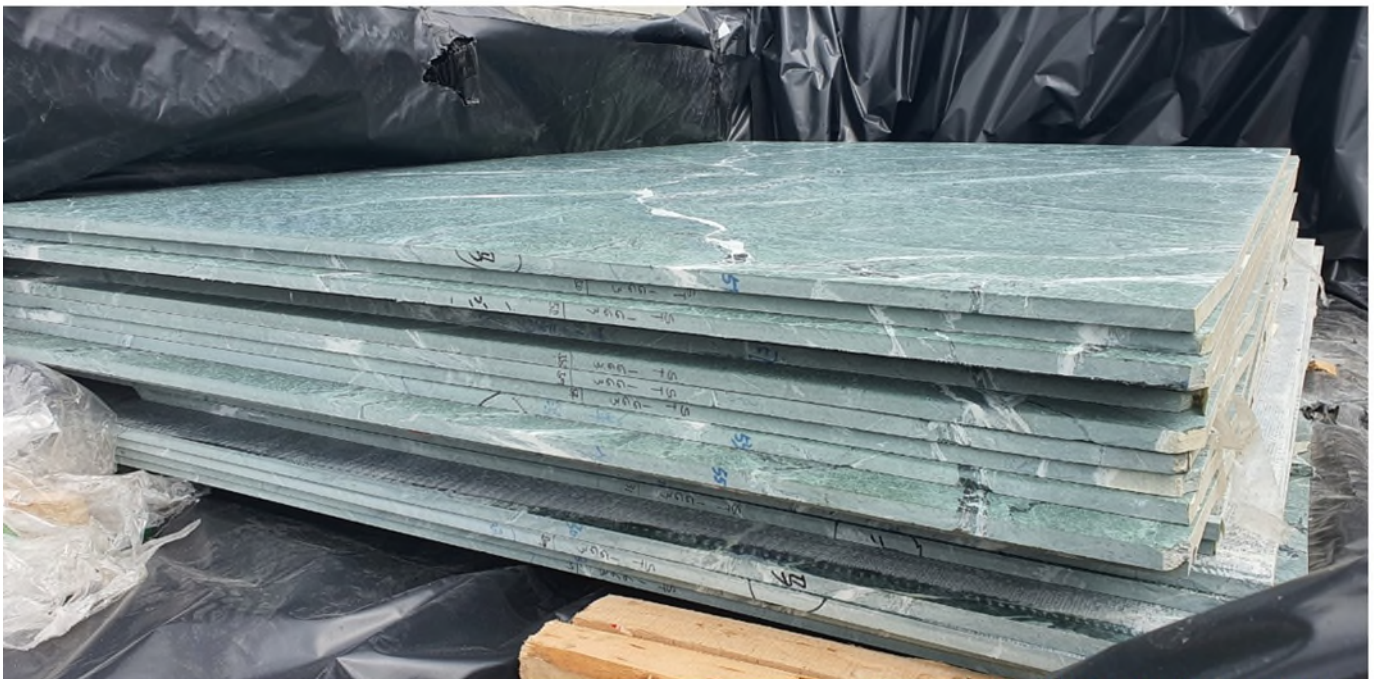
9. Naturally occurring chrysotile asbestos and actinolite asbestos in mineral slabs described as China Jade Green marble. Country shipped from: China.

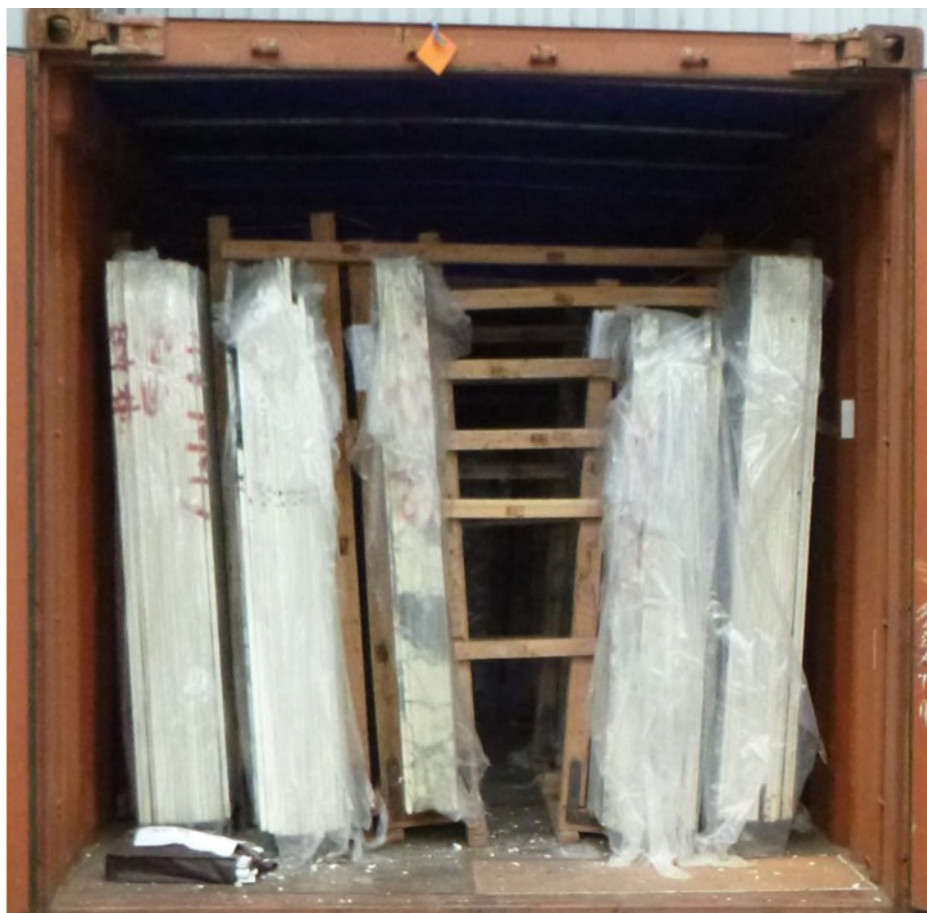
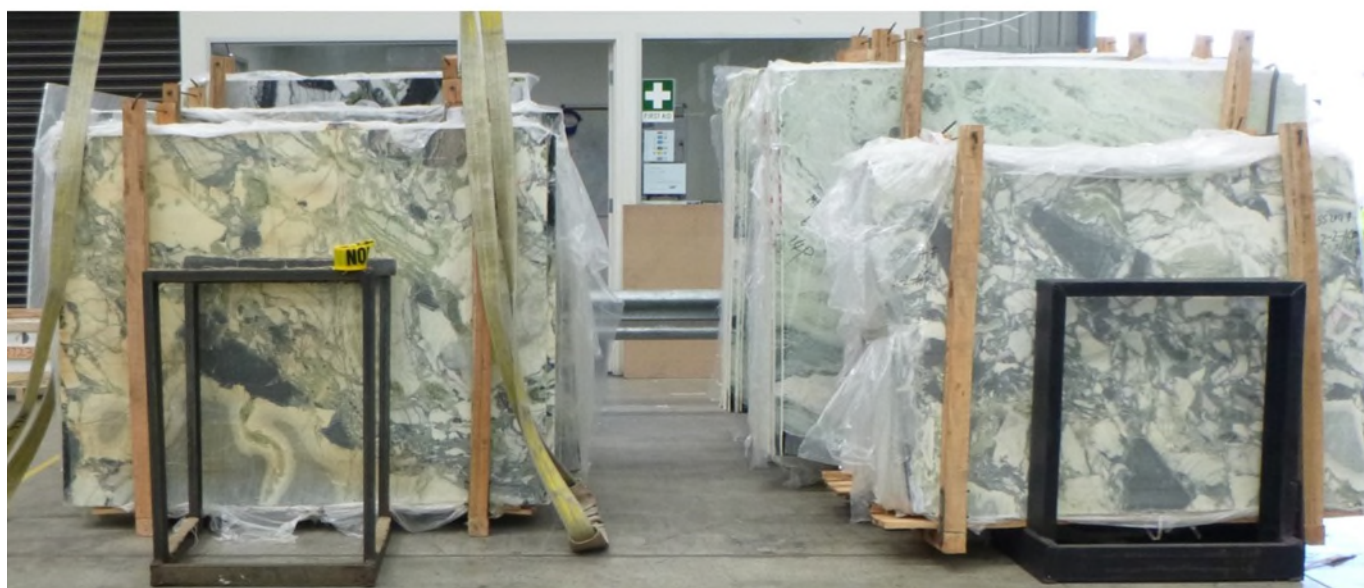
10. Naturally occurring chrysotile asbestos in mineral slabs described as Ice Green Marble and Jade Green Marble. Country shipped from: China.

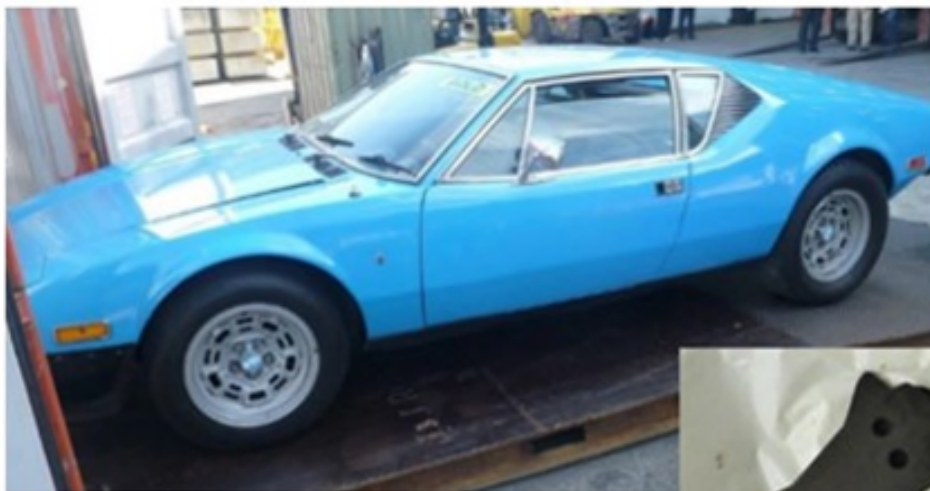
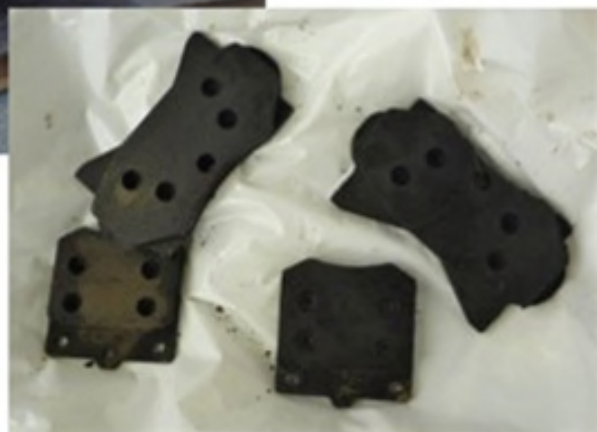
11. Chrysotile asbestos detected in the brake pads of a 1973 DeTomaso Pantera.
Country shipped from: USA

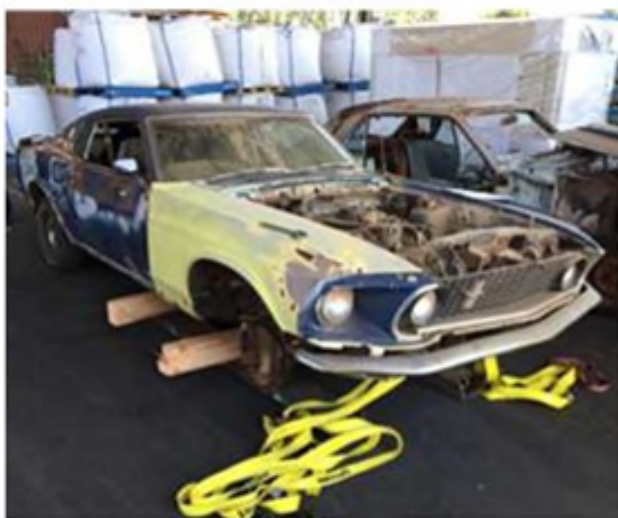
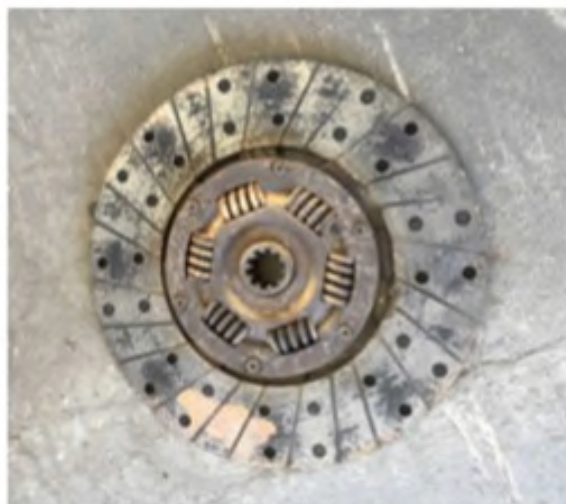
12. Chrysotile asbestos detected in the clutch plate of a 1969 Ford Mustang.
Country shipped from: USA.

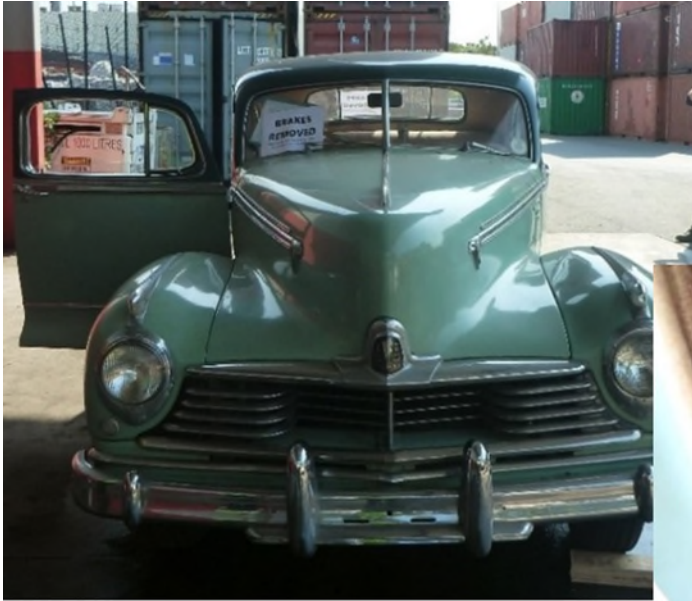
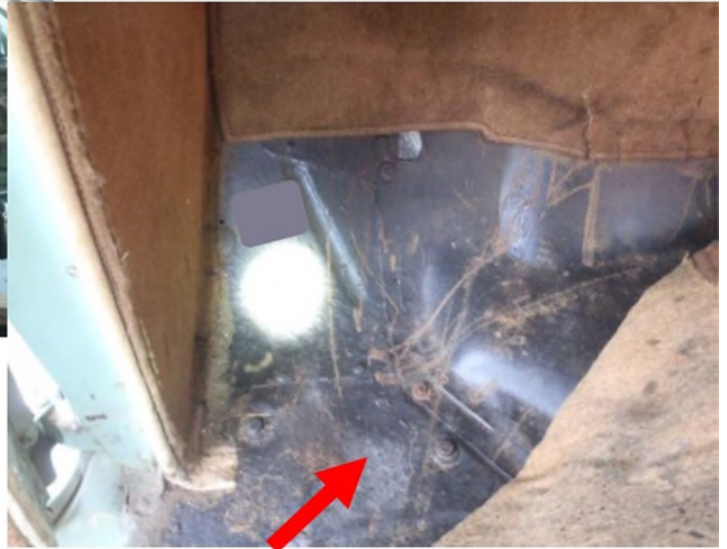
13. Chrysotile asbestos detected in bituminous coating painted on to the floor pan of a 1947 Hudson Commodore. Country shipped from: USA

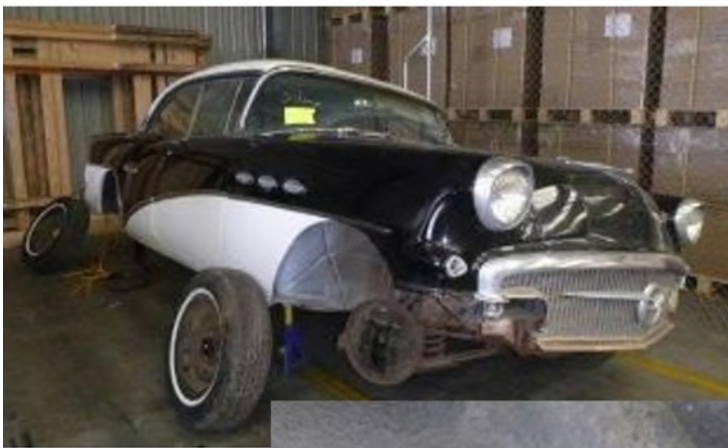
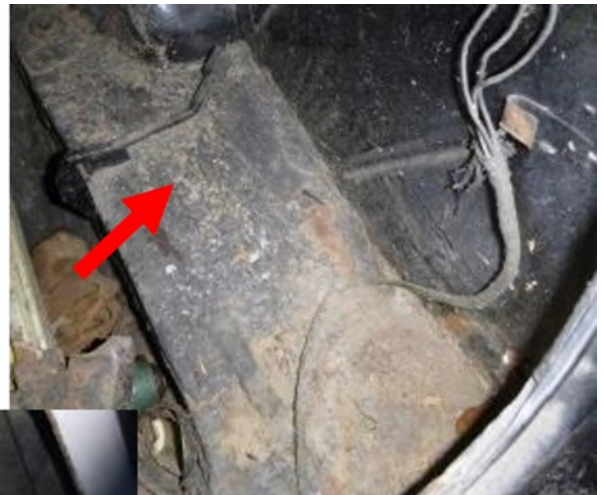
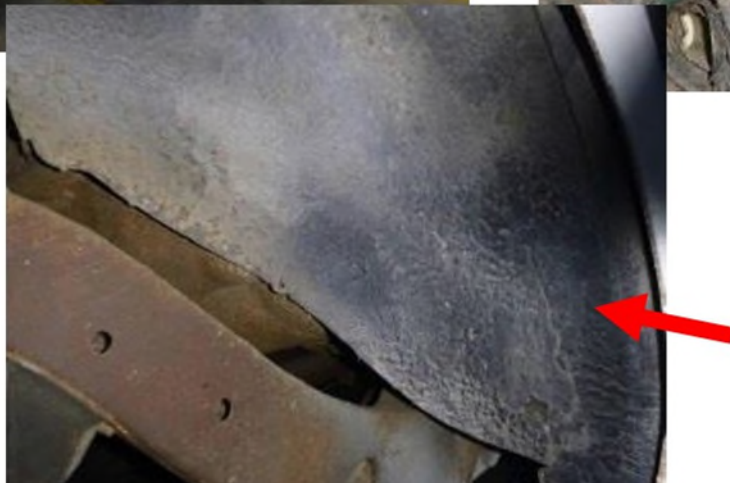
14. Chrysotile asbestos detected in bituminous layer in boot and underbody of a 1956 Buick Century. Country shipped from: USA.

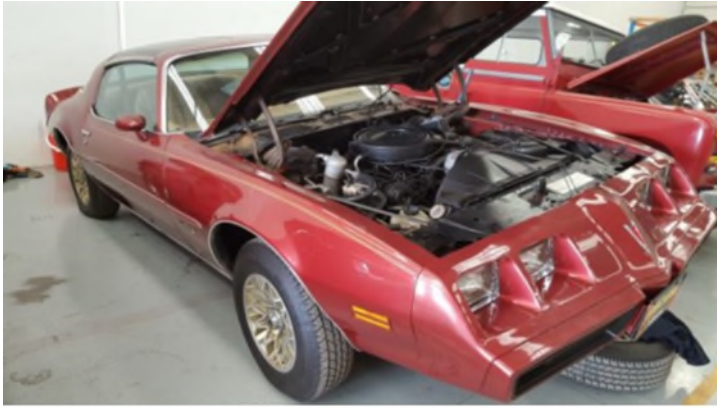
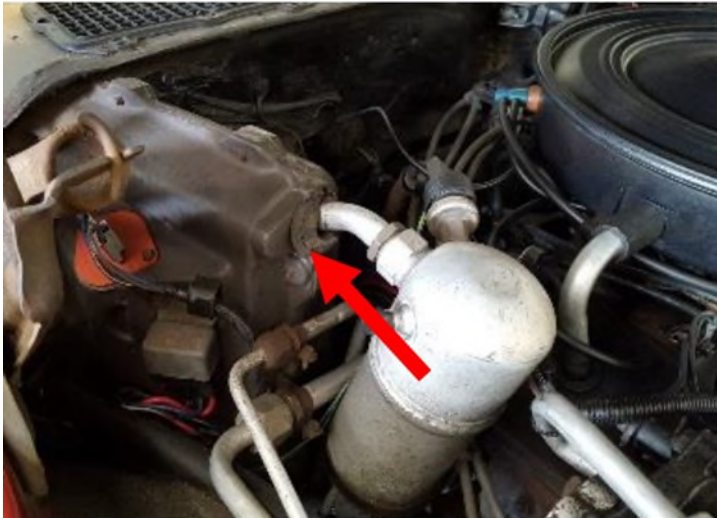
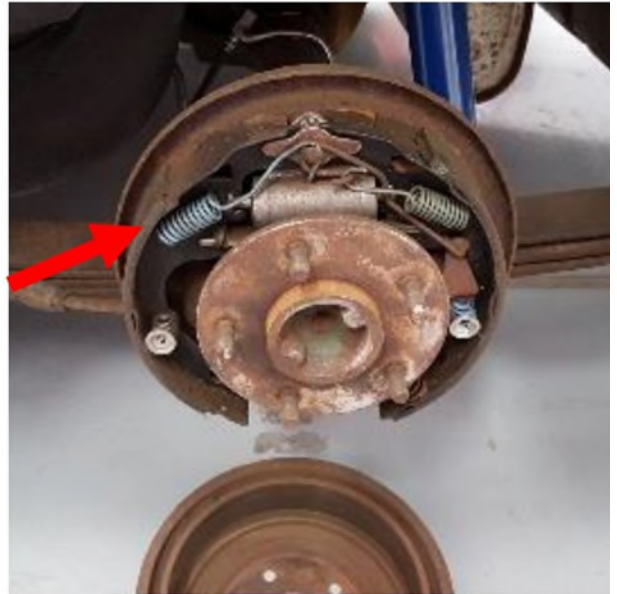
15. Chrysotile asbestos detected in a 1979 Pontiac Firebird: rear brake shoes and bituminous material used as an air conditioner seal and insulation. Country shipped from: USA

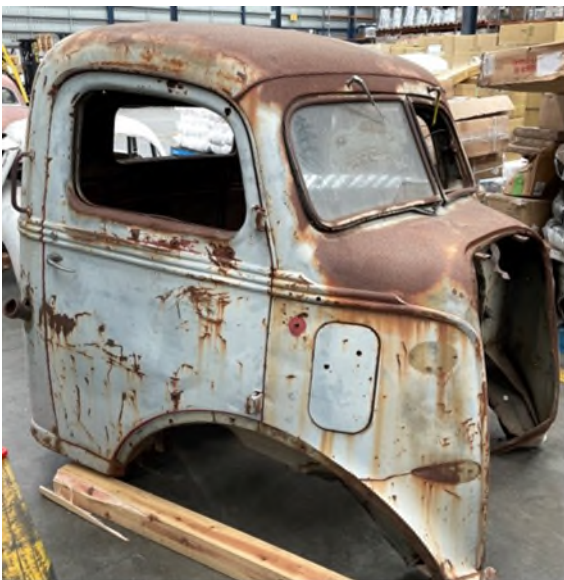
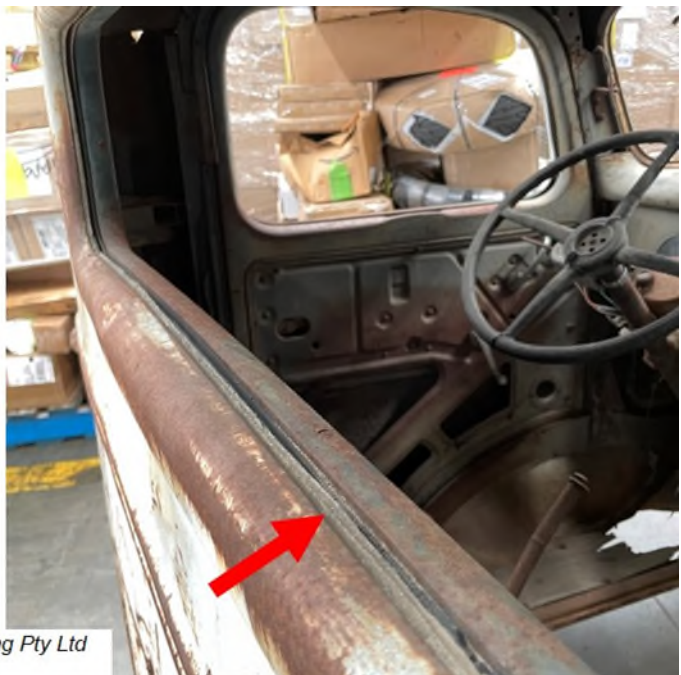
16. Chrysotile asbestos detected in the rear window seals of a 1938 Ford truck cabin.
Country shipped from: USA

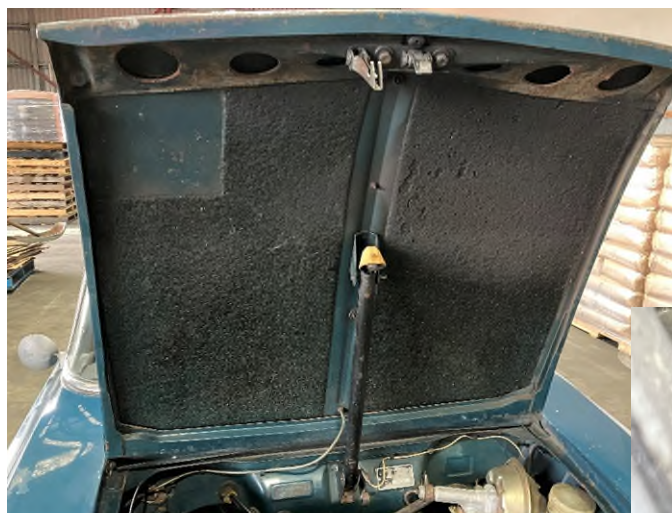
Under-bonnet insulation

17. Chrysotile asbestos detected in 1965 Alfa Romeo Giulia Ti. Country shipped from: United Kingdom.
