Australian
BORDER FORCE

Detections of asbestos in imported goods

The following images are examples of imported goods which were subjected to sampling and testing at the border, and subsequently found to contain asbestos. The *Country shipped from* is the country the goods were supplied from to Australia. For some of the vehicle examples, this does not reflect the original country of manufacture.

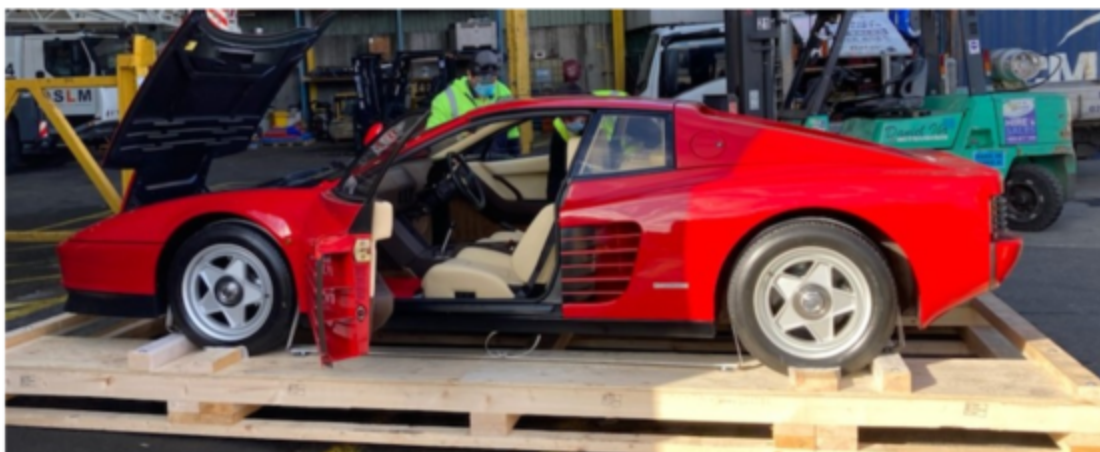
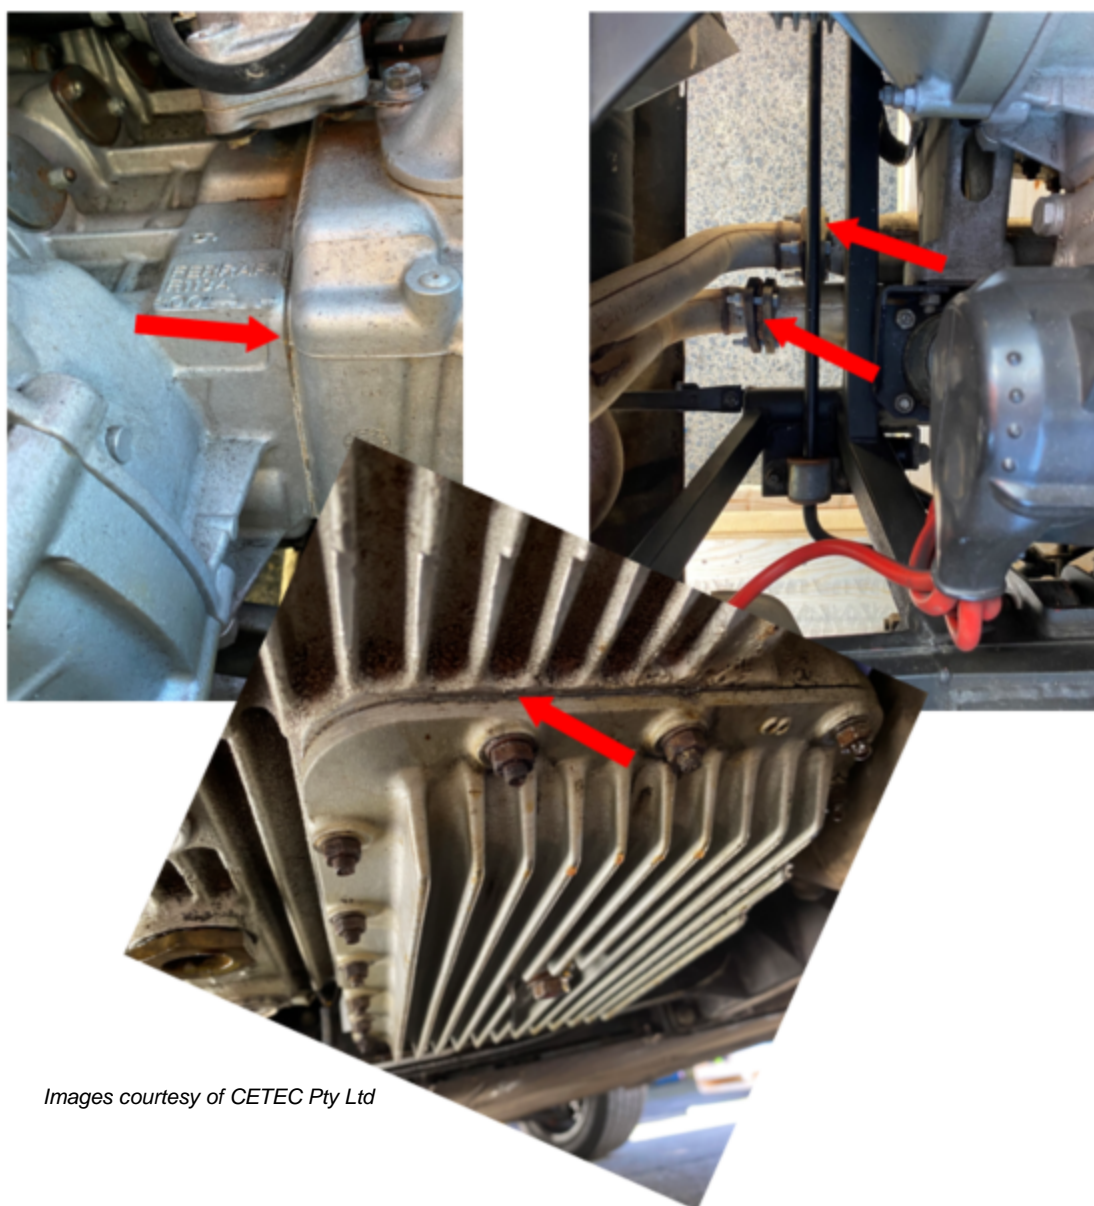
18. Chrysotile asbestos detected in various gaskets of 1986 Ferrari Testarossa.
Country shipped from: United Kingdom.

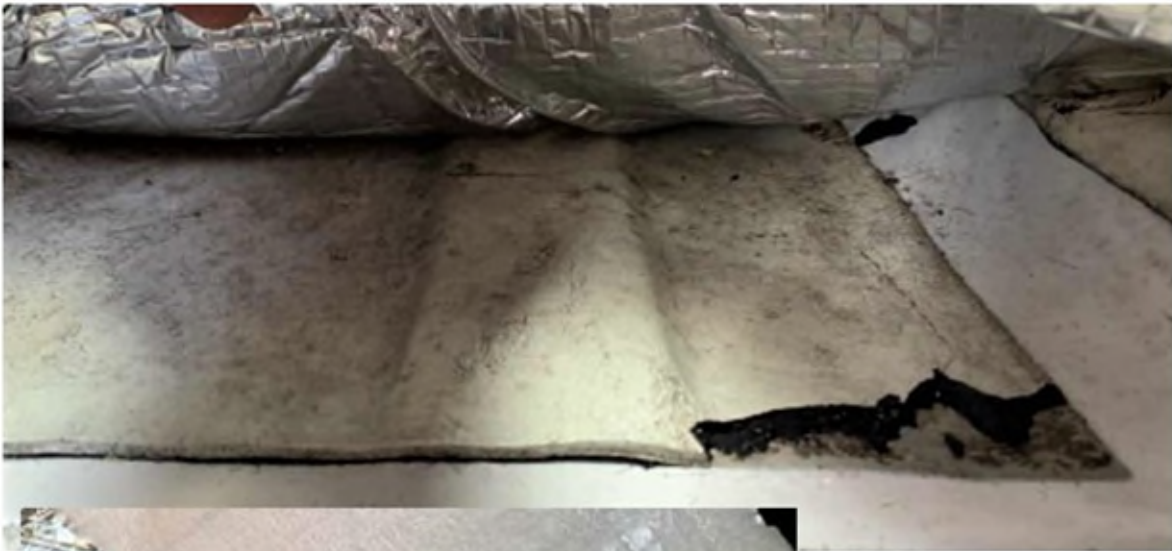
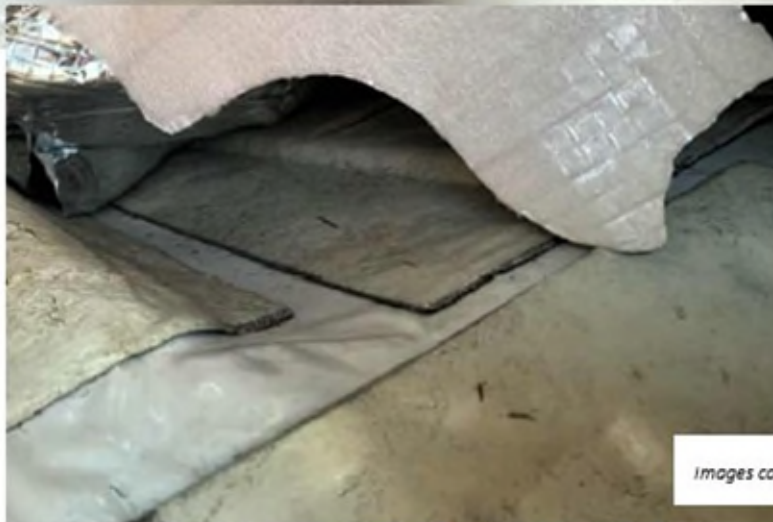
Acoustic padding

19. Chrysotile asbestos in after-market acoustic padding (sound deadening) under seats and within a bituminous mastic painted onto the boot, of used 1975 Nissan Fairlady Z (known in Australia as Datsun 240Z). Country shipped from: Japan.

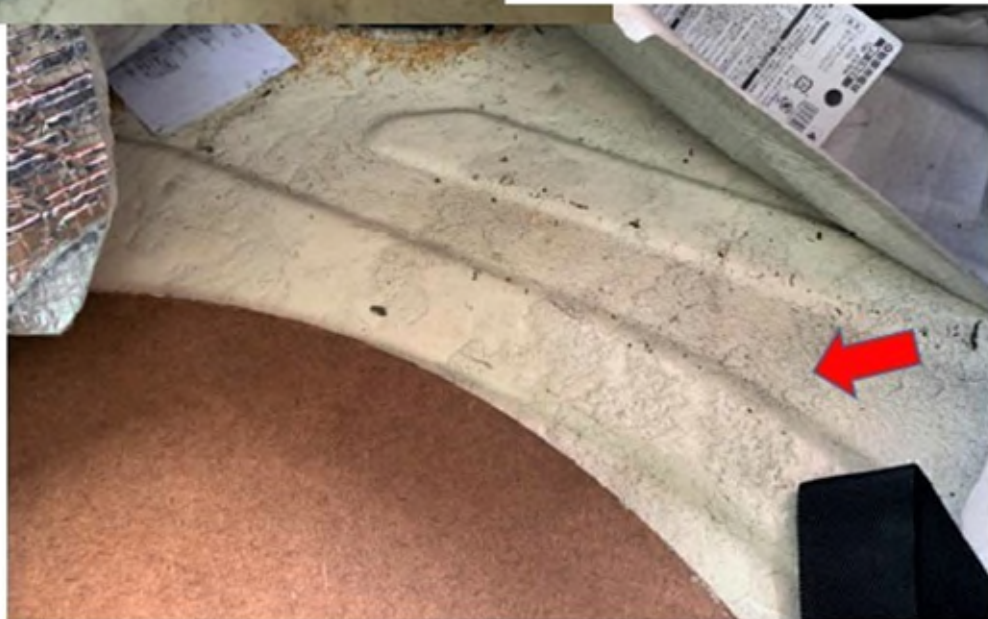
Bituminous mastic painted onto interior of boot

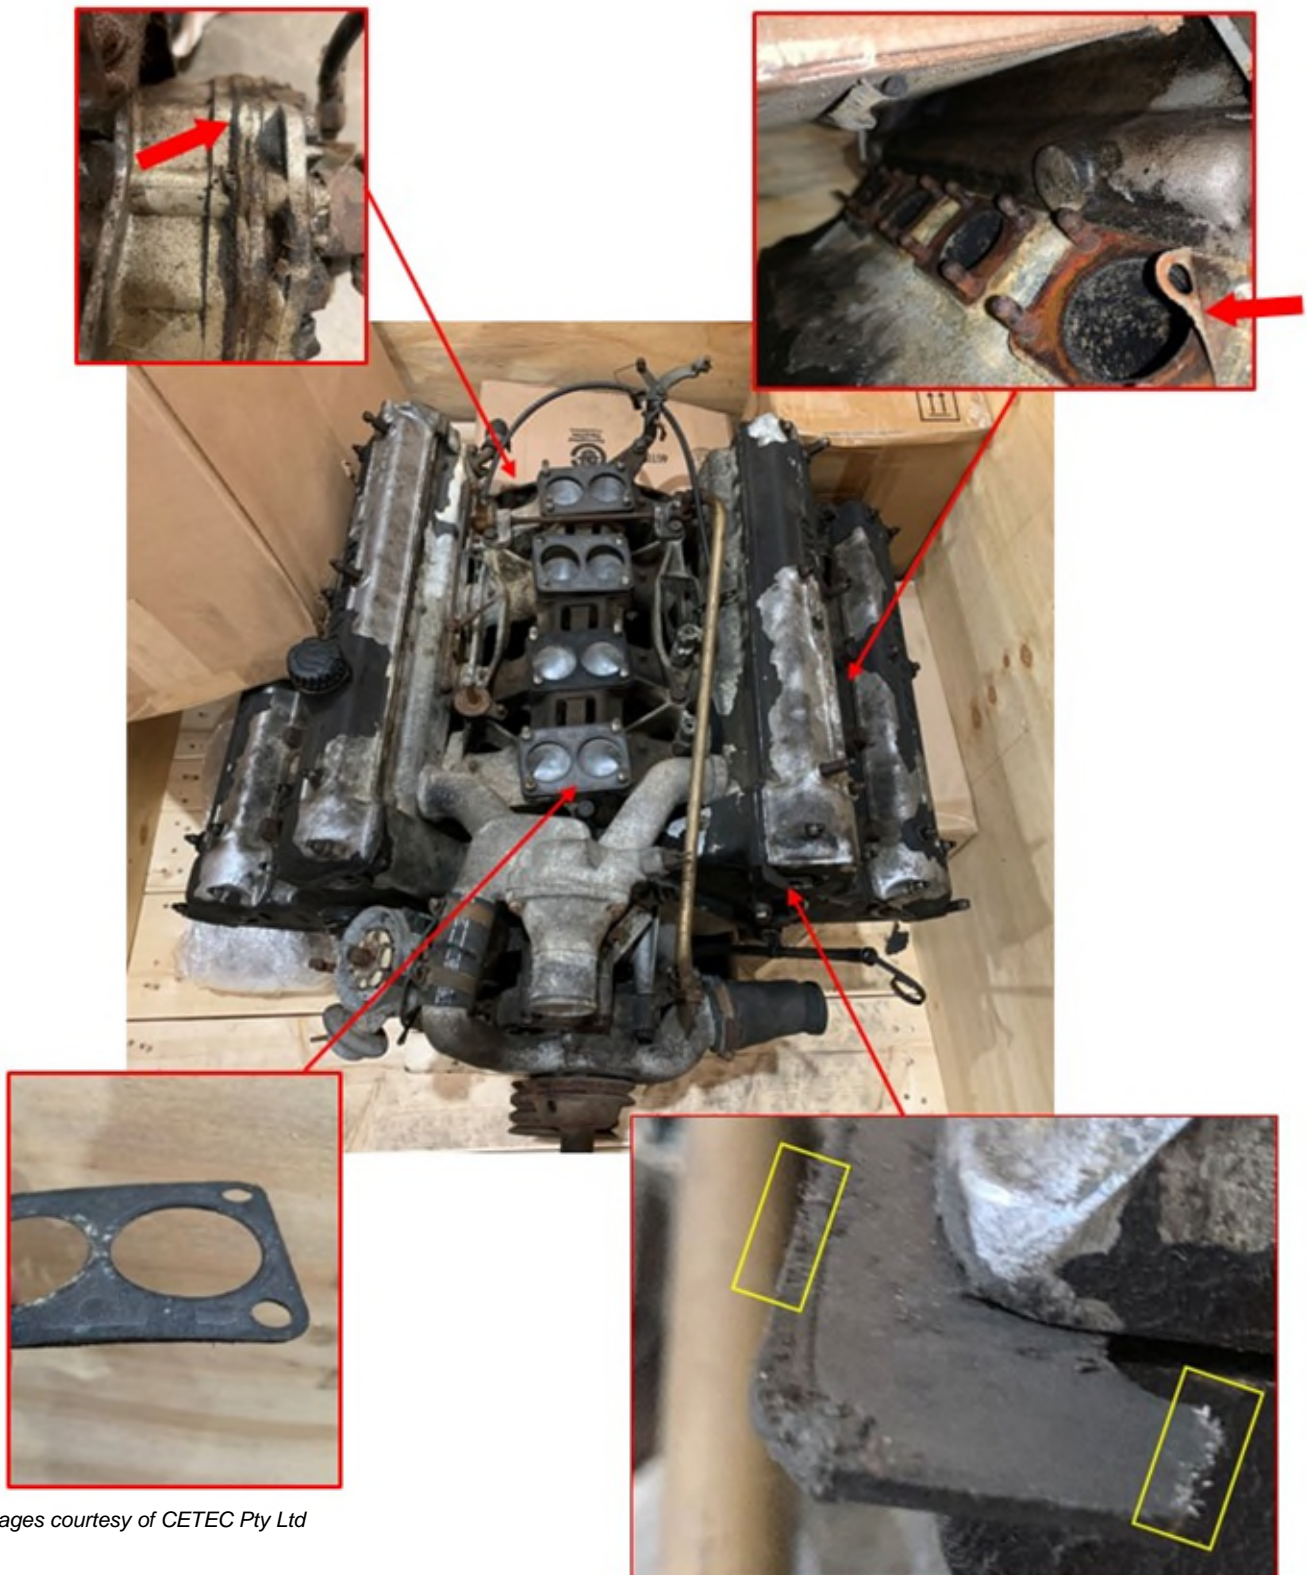
20. Chrysotile asbestos in gaskets within used Maserati Quattroporte III 4.9L V8 Engine.
Country shipped from: United Kingdom.

Visible fibres indicated

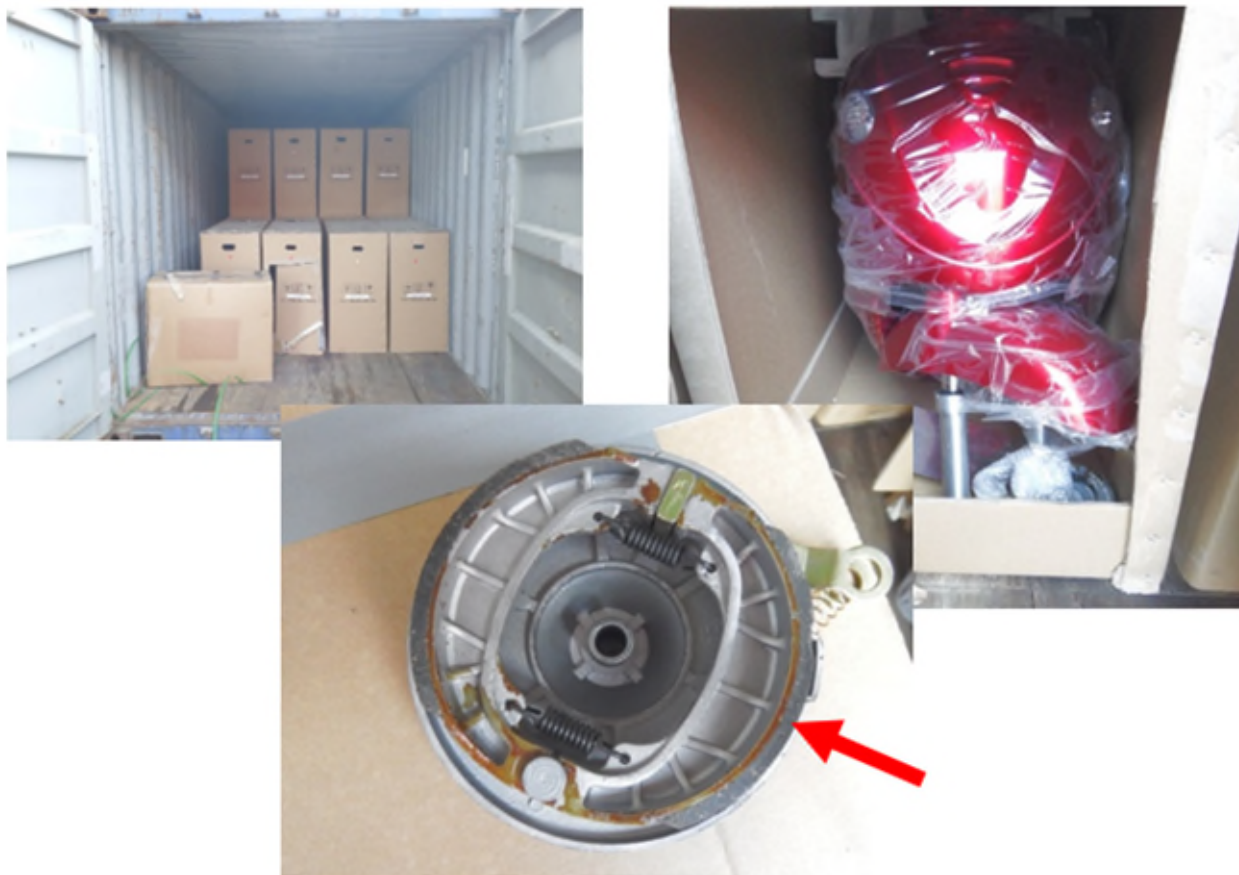
21. Chrysotile asbestos detected in brake shoes of new 'Electric Bicycles' which had the appearance of motor scooters. Country shipped from: China.

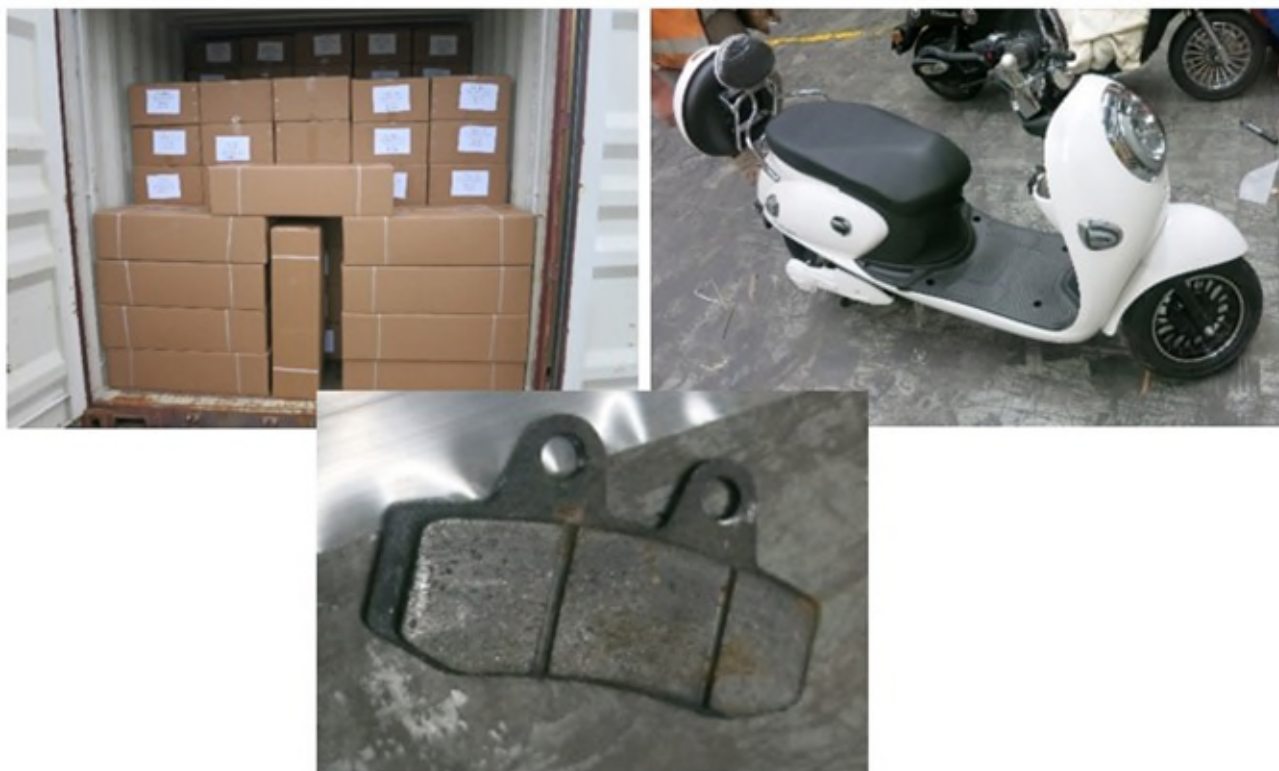
22. Chrysotile asbestos detected in brake pads of new 'Electric Bicycles' which had the appearance of motor scooters. Country shipped from: China.

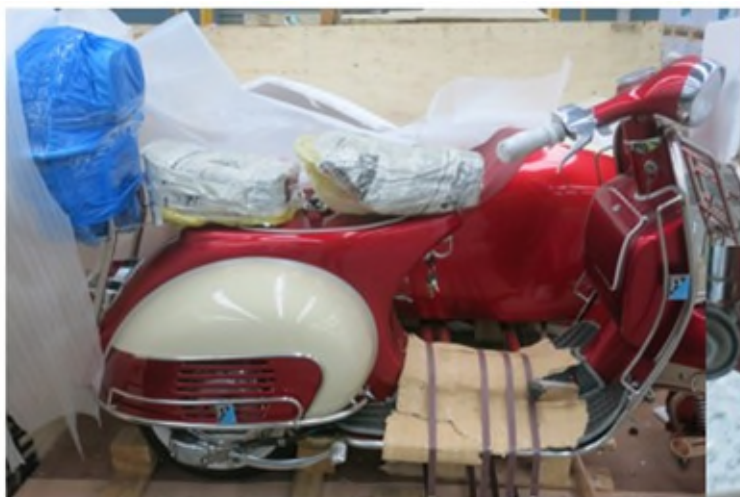
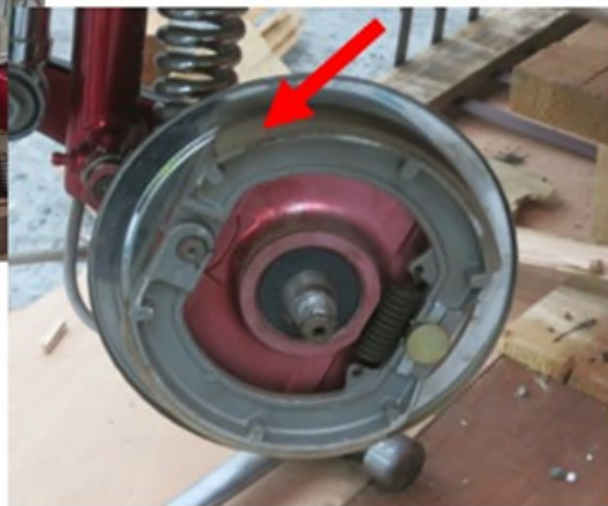
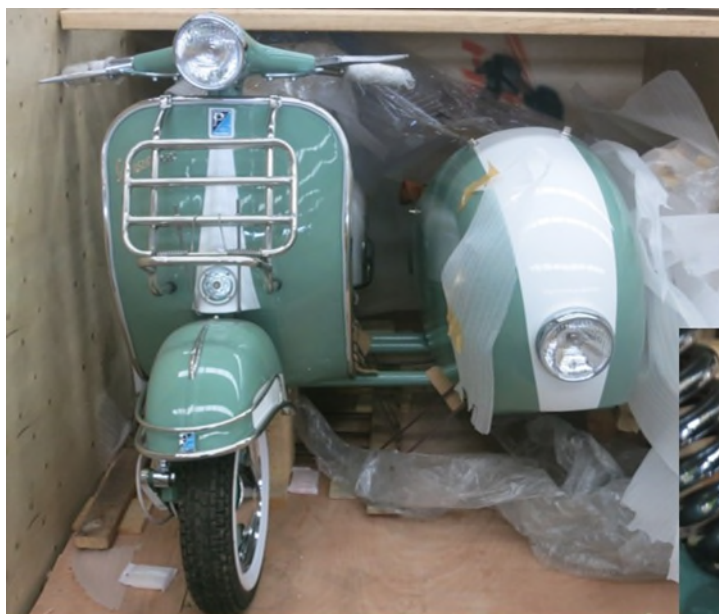
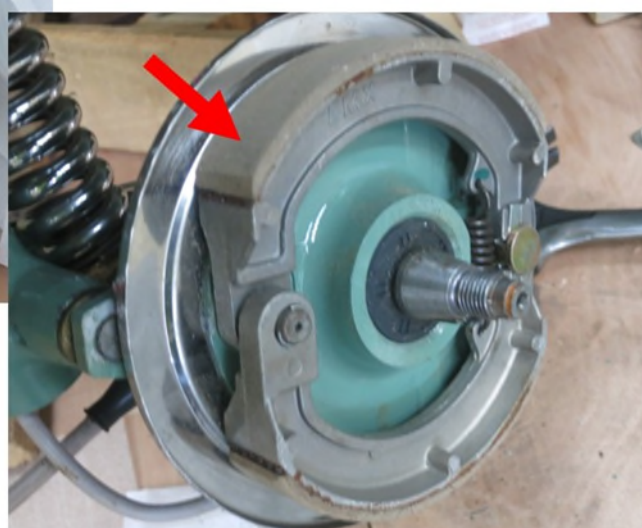
23. Chrysotile asbestos detected in new brake shoes of reconditioned used Vespa motor scooters.
Country shipped from: Vietnam

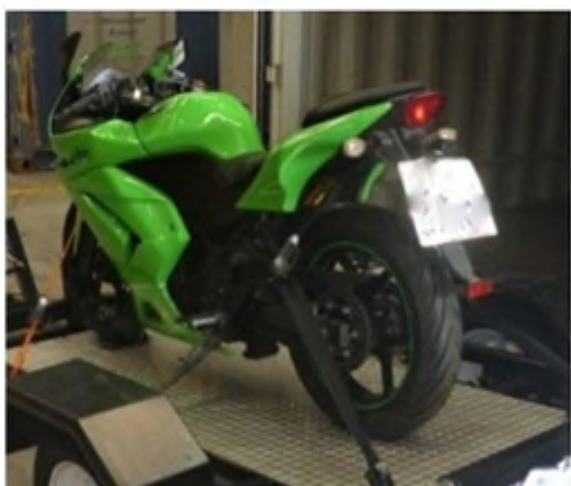
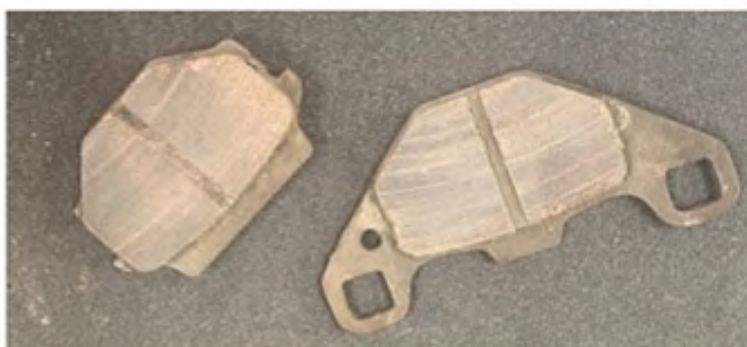
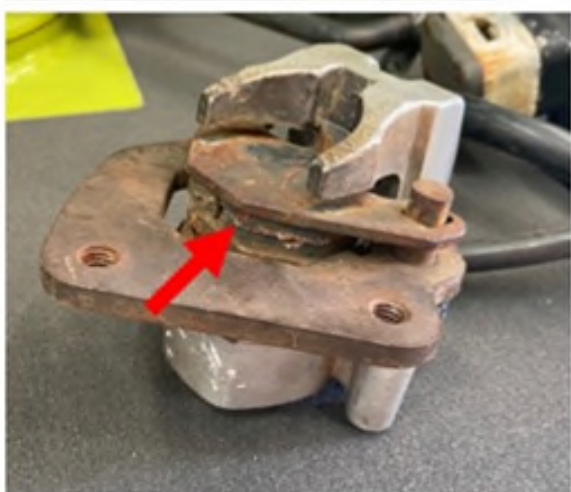
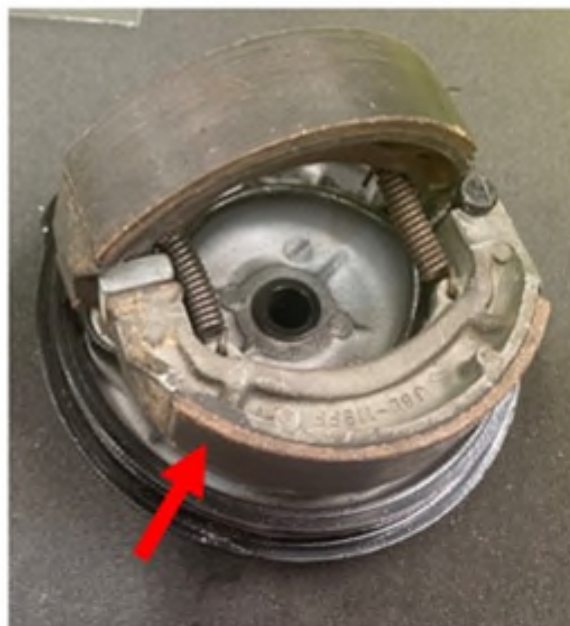
24. Chrysotile asbestos detected in brake drums, brake pads and caliper brake of a used Kawasaki motorcycle. Country shipped from: South Africa

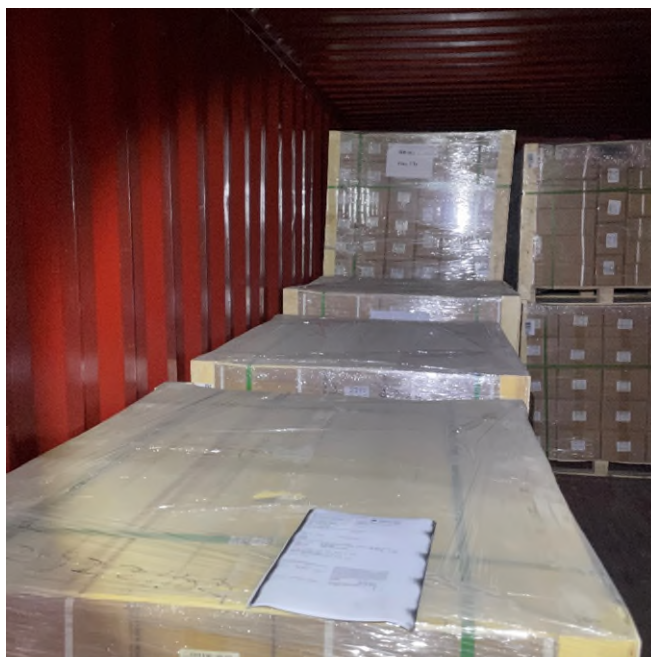
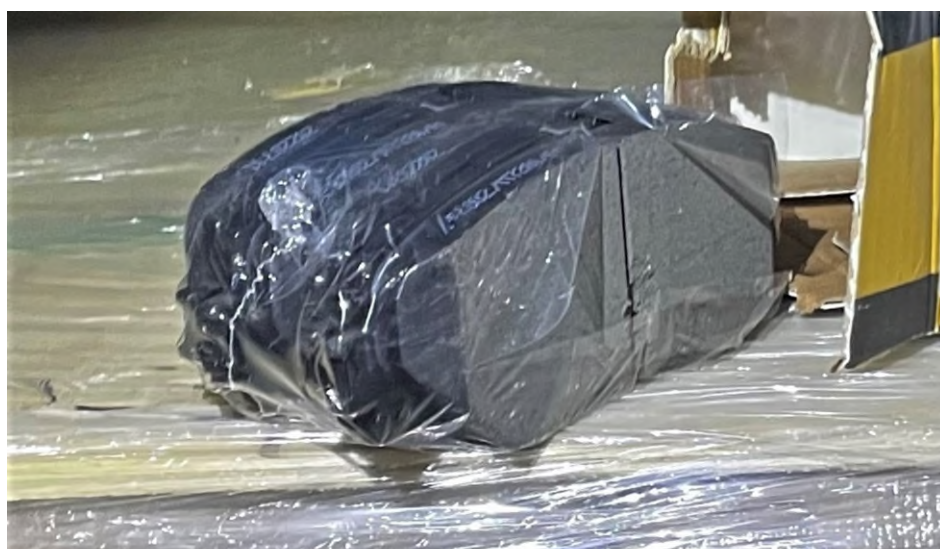
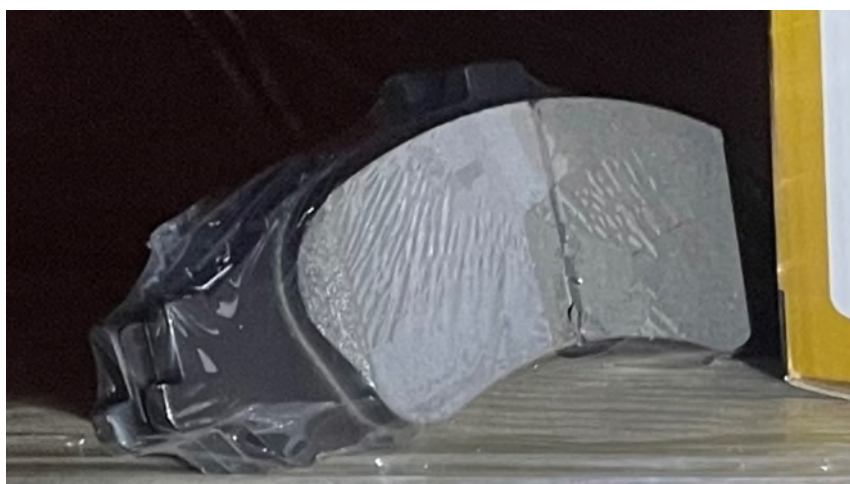
25. Chrysotile asbestos detected in consignment of new after-market disc brake pads. Country of manufacture and shipped from: China.

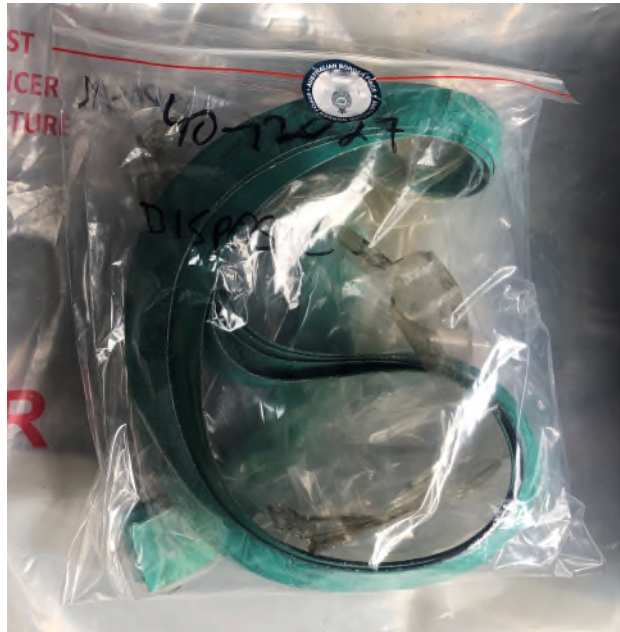
26. Chrysotile asbestos detected in after-market gasket for industrial 500HP mud pump. Country shipped from: China.

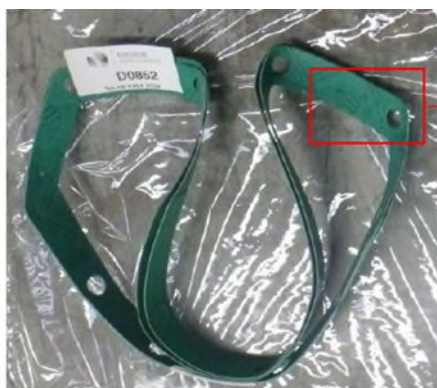
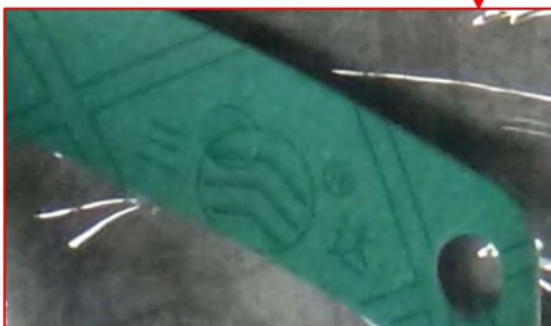
After-market gasket 144-33-21340 with manufacturer markings

27. Chrysotile asbestos detected in after-market gaskets for use within construction plant components: Steering Case Cover and Part the Brake Piping with brake assistor. Both gaskets are compatible with a number of Komatsu and Shantui construction plant models. Country shipped from: China.

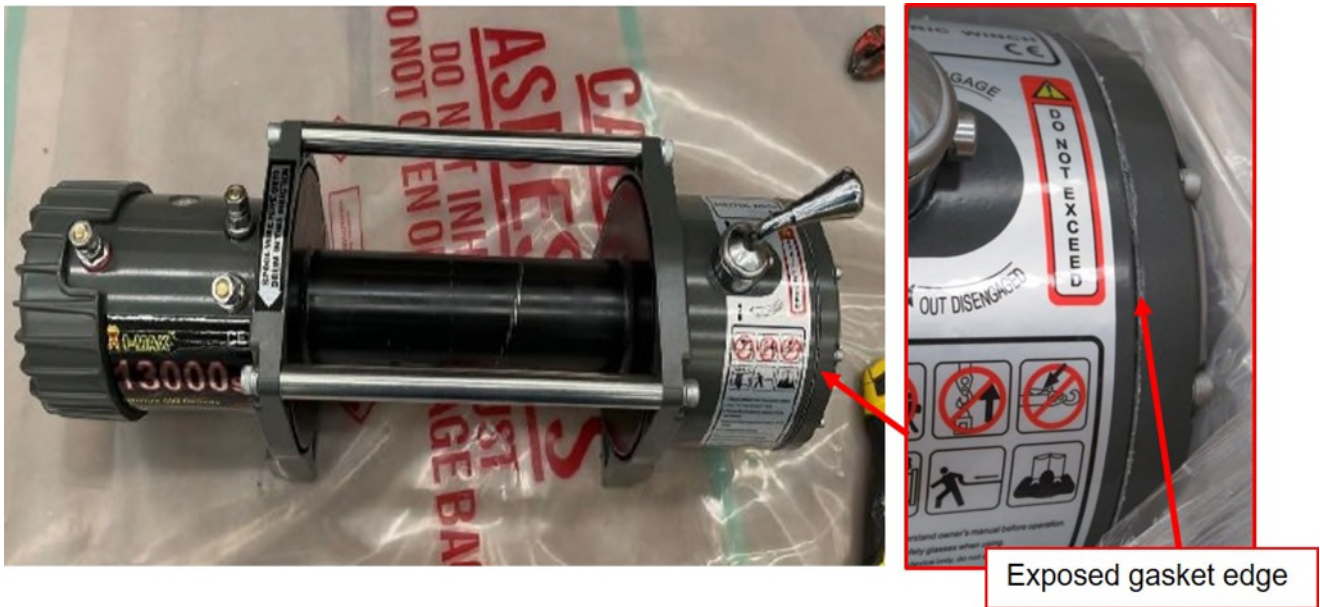
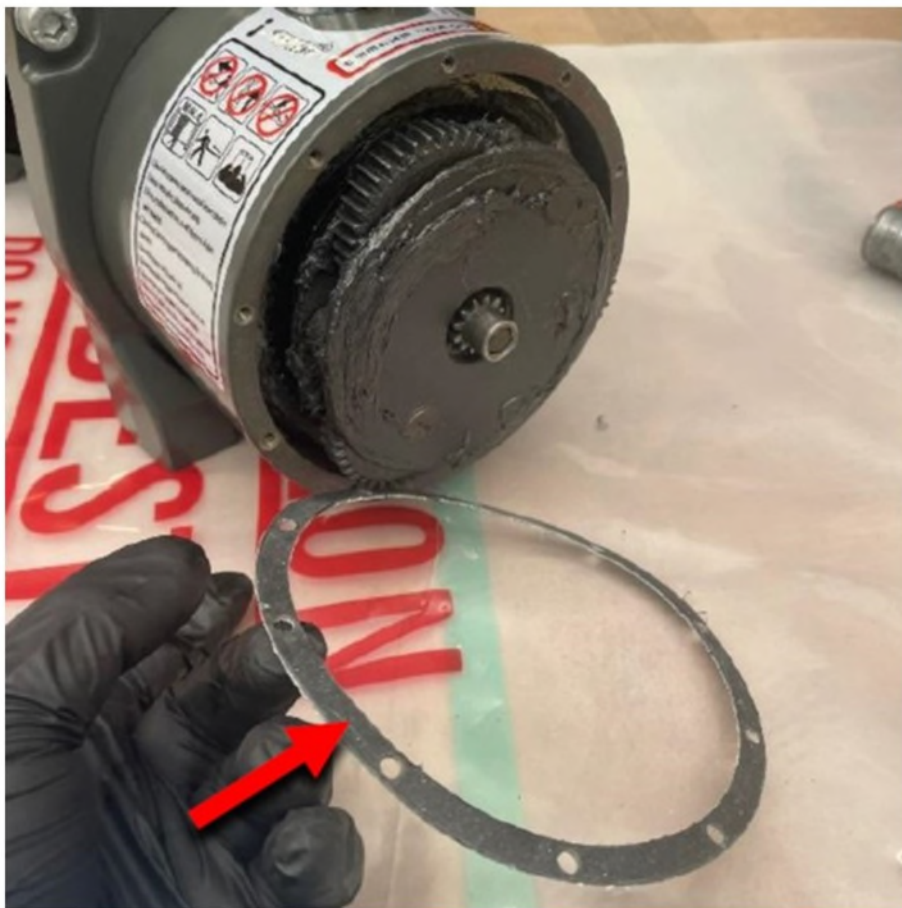
28. Chrysotile asbestos detected in gasket seal for electric winch designed for 4WDs and boats.
Country shipped from: China.

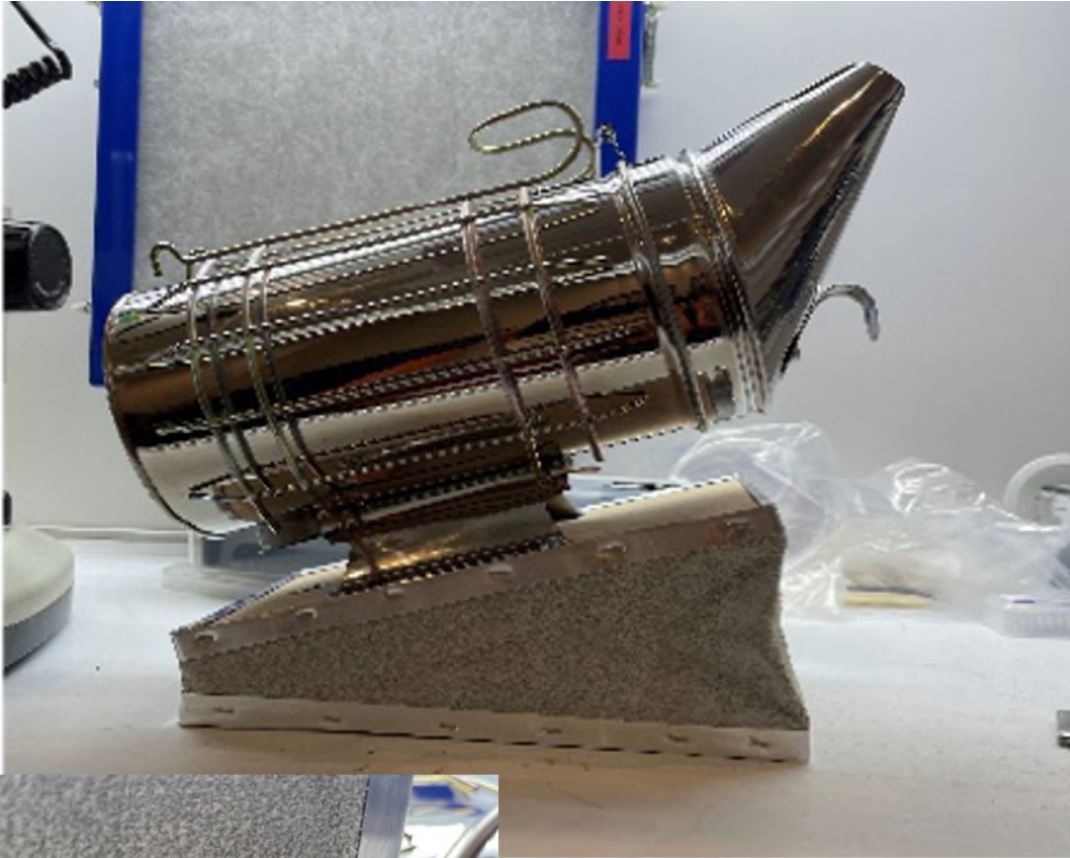
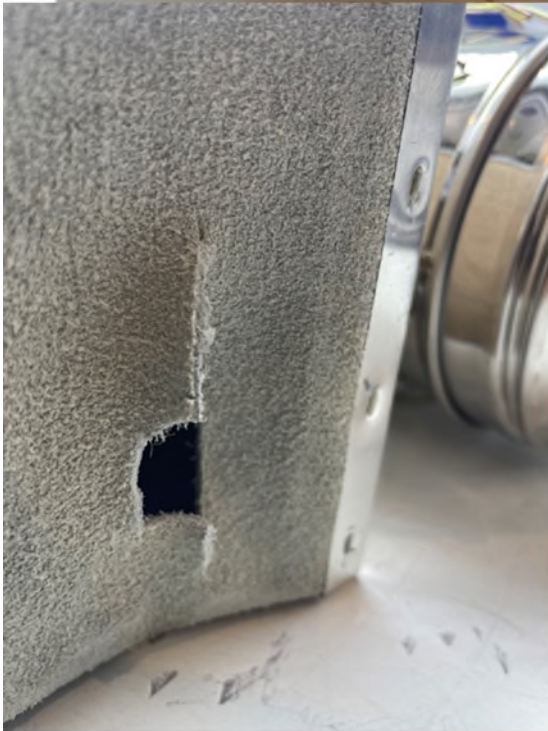
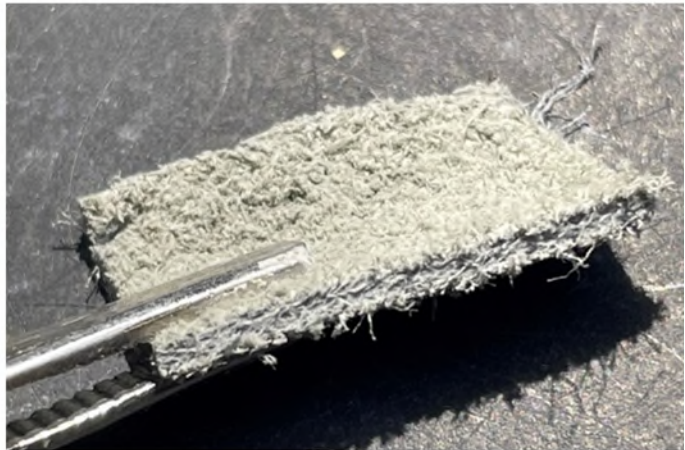
29. Chrysotile asbestos detected in woven material within the bellows component of manual bee smokers (used by bee keepers). Country shipped from: China.
